The primary objective of this project was to determine the condition of the two World Trade Center (WTC) towers immediately following the aircraft impacts. This assessment includes both the determination of the structural damage that degraded their strength and the condition and position of nonstructural contents such as partitions, workstations, aircraft fuel, and other debris that influenced the behavior of the subsequent fires in the towers. The global impact analyses were the primary method by which most of the information on the tower damage was obtained. The analyses described in the other chapters of this report, such as the component and subassembly impact analyses, were performed to support the development and validation of these global impact models.

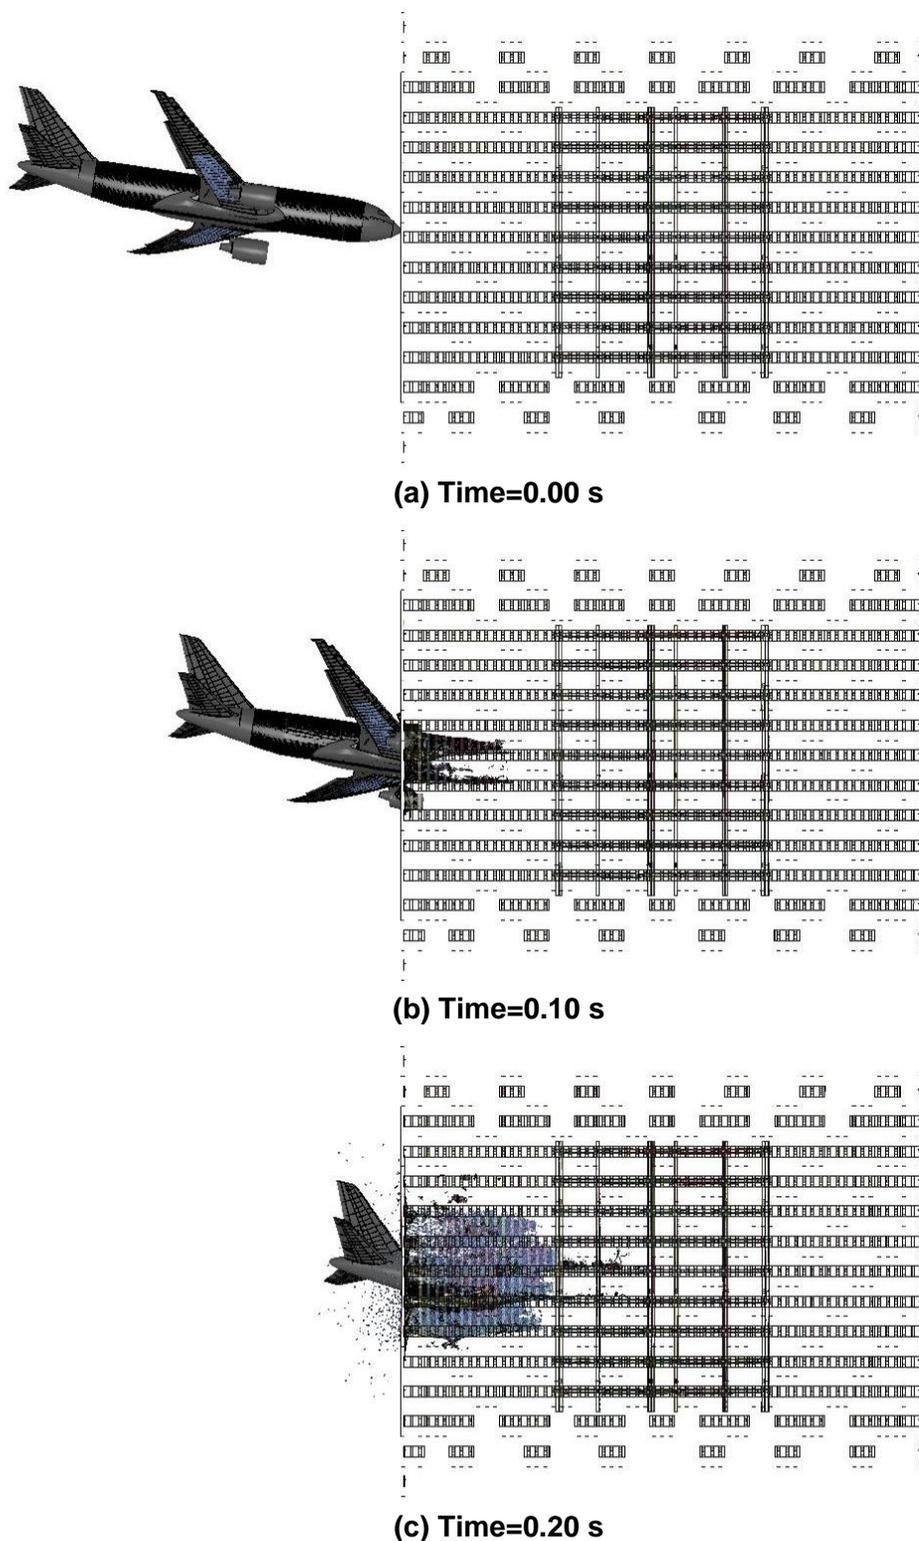
Figure 9–4. WTC 1 base case global impact analysis (side view).

The initial 0.1 s of the base case global aircraft impact response, shown in Figure 9–4(b) and Figure 9–5(b), was dominated by the impact, penetration, and fragmentation of the forward fuselage structures. The engines and wing sections were just starting to impact the exterior wall. The forward fuselage structures were severely damaged both from the penetration through the exterior columns and the penetration of the 96th floor slab that sliced the fuselage structures in half. The downward trajectory of

the aircraft structures caused the airframe to collapse against the floor, and the subsequent debris motion was redirected inward along a more horizontal trajectory parallel to the floor.

At 0.3 s after impact, the aircraft was completely inside of the tower (full penetration completed at approximately 0.25 s), as shown in Figure 9–4(d) and Figure 9–5(d). The airframe was mostly broken up, but some large sections of the aft fuselage and tail were still intact, having penetrated through the opening in the tower wall produced by the forward fuselage structures. The aircraft fuel cloud penetrated approximately half the distance through the core and was spreading out. However, the subsequent motion of the aircraft fragments and fuel debris cloud began to be noticeably slowed beyond this time. The fuel and debris did continue to spread through the tower, but at a much slower rate, as seen in the remaining images in Figure 9–4 and Figure 9–5.

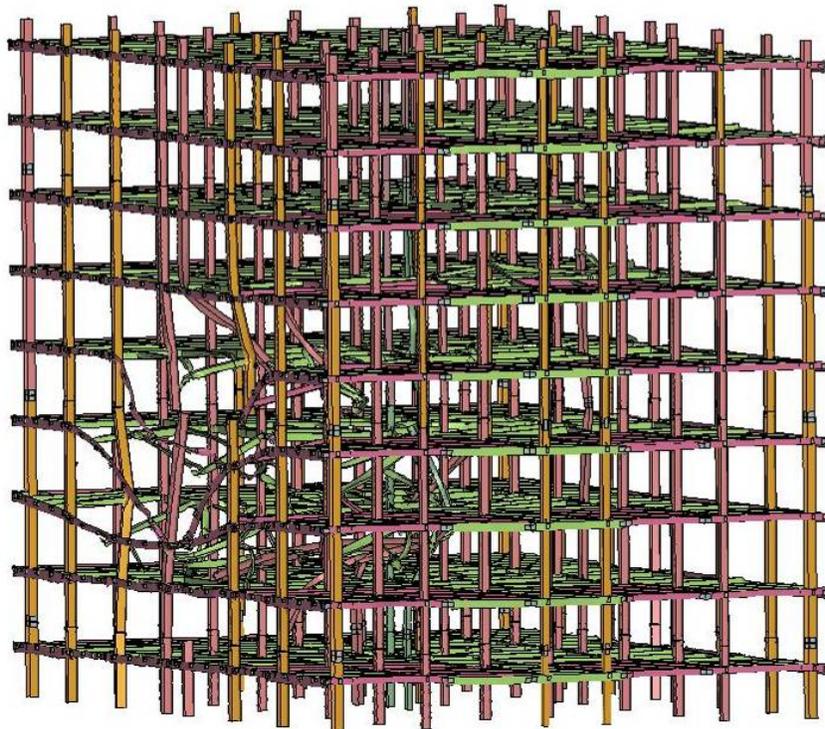
Figure 9–50. More severe impact response of the WTC 1 core.

(a) Initial geometry

(a) Calculated impact damage

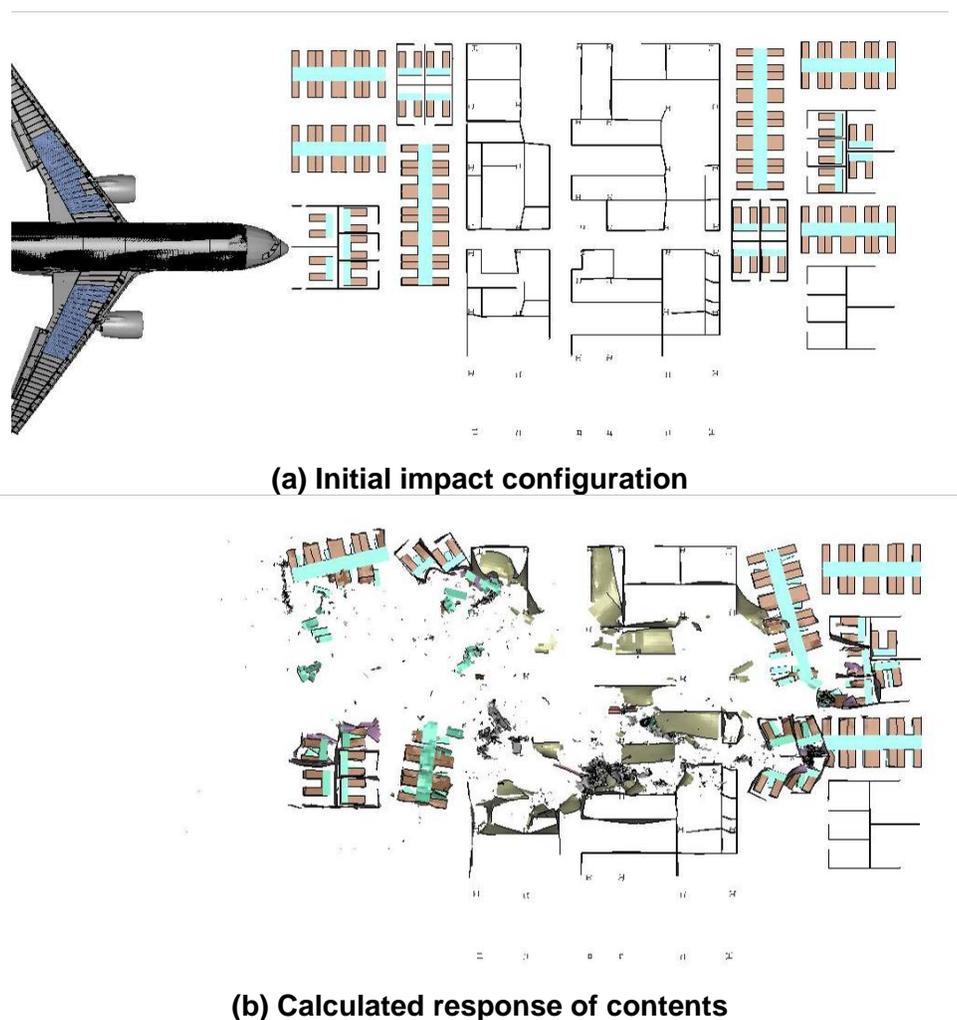
Figure 9–57. Calculated more severe WTC 1 impact response of floor 94 contents.

The calculated damage to the WTC 1 contents for the more severe impact is shown in plan views in Figure 9–57 through Figure 9–61 for floors 94 through 98, respectively. A comparison to the calculated damage for the base case WTC 1 impact analysis, shown previously in Figure 9–20 through Figure 9–24, indicated that the content damage zone is very similar in width but extended further south through the tower in the more severe impact. The more severe impact produced significantly greater content damage on the far side of the core and extended more fully through the tower.

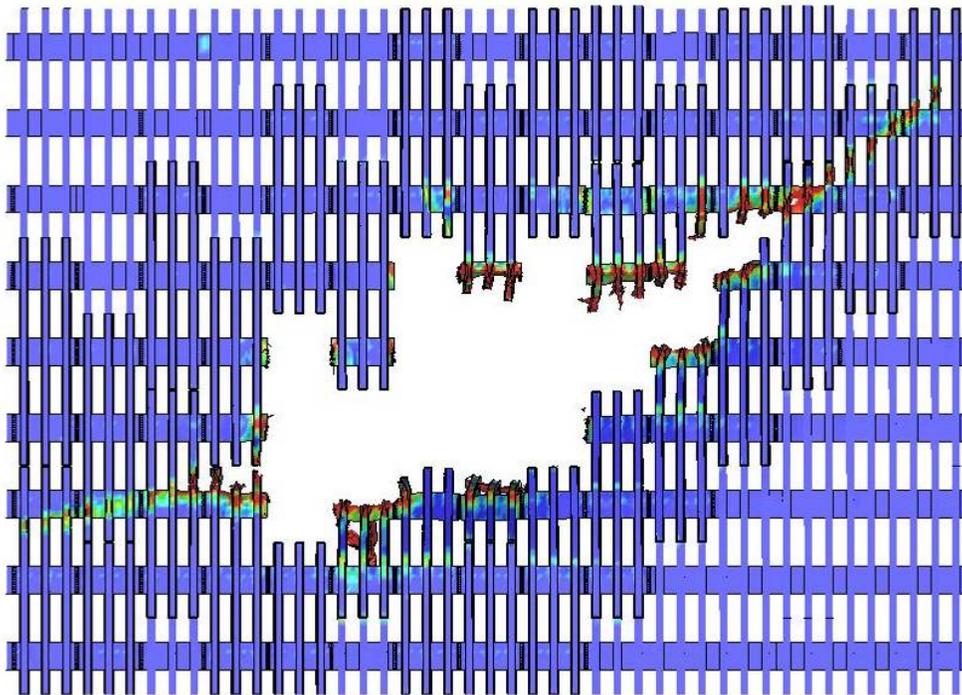
A comparison of the north exterior wall observed and calculated damage from the less severe WTC 1 global impact analysis is shown in Figure 9–62. The calculated impact damage to the exterior wall is shown with color fringes representing plastic strain magnitude, with undamaged sections in blue and strains at or above 5 percent shown in red. The wall regions shown in Figure 9–62 are from column 108 to column 152, extending from floor 91 to floor 100 (spandrels at floors 92 through 100). The magnitude and mode of impact damage on the exterior wall were still in good agreement with the observed damage for this less severe impact scenario.

(a) Schematic of observed damage

(b) Calculated damage (t=0.735 s)

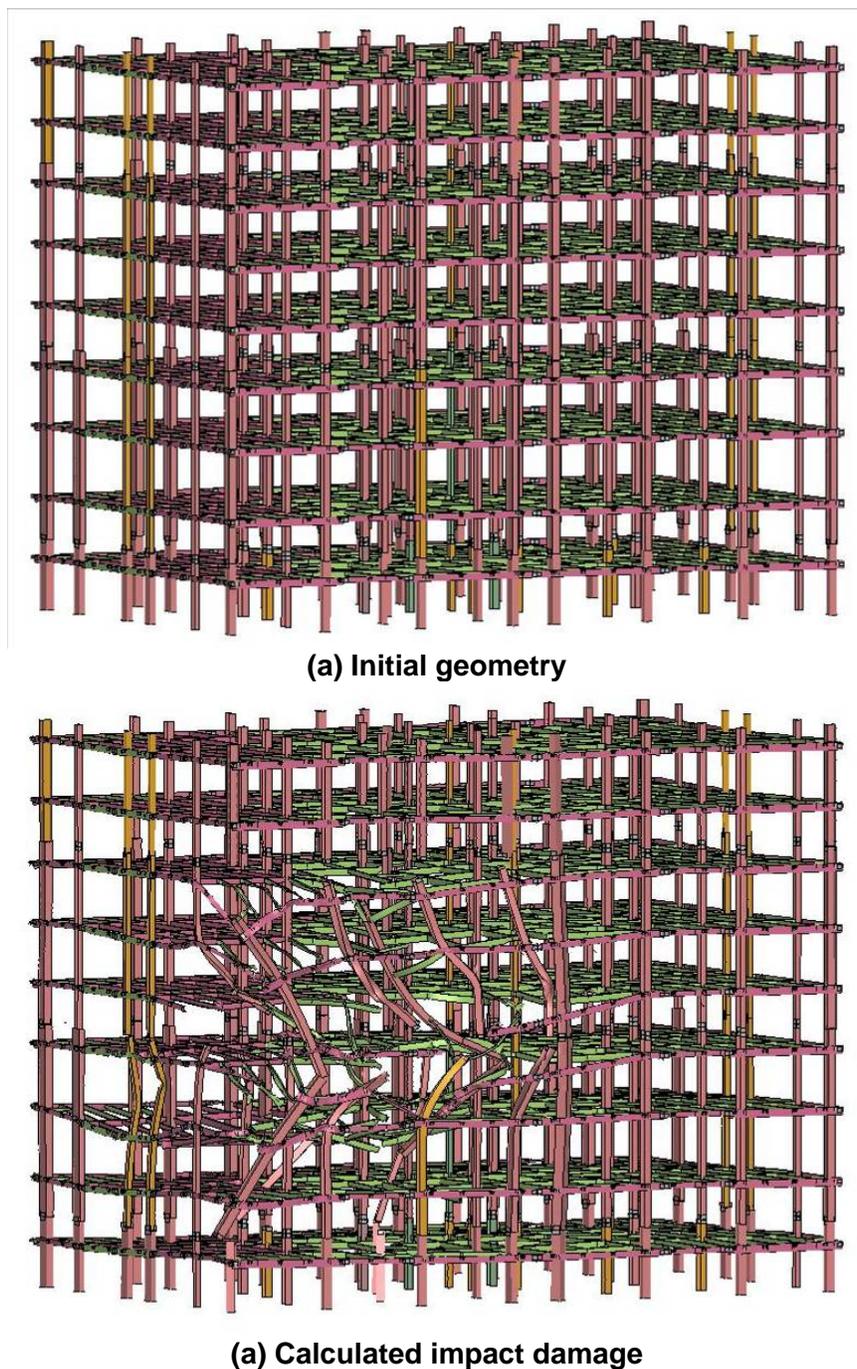
Figure 9–78. More severe impact response of the WTC 2 core.

The calculated damage to the core columns by row is shown in Figure 9–79, and the floor-by-floor damage to the core framing is shown in Figure 9–80. The core structures are shown with color fringes representing plastic strain magnitude, with undamaged sections in blue and strains at or above 5 percent shown in red. A summary of the column damage is provided in Table 9–11 and shown graphically in Figure 9–81, with the qualitative classification of the column damage levels provided previously in Figure 9–12. A total of 10 columns were severed, and one column was heavily damaged, compared to five columns severed and four columns heavily damaged in the base case WTC 2 impact analysis.
