NIST NCSTAR 1-2B

**Federal Building and Fire Safety Investigation of the
World Trade Center Disaster**

Analysis of Aircraft Impacts into the World Trade Center Towers

September 2005

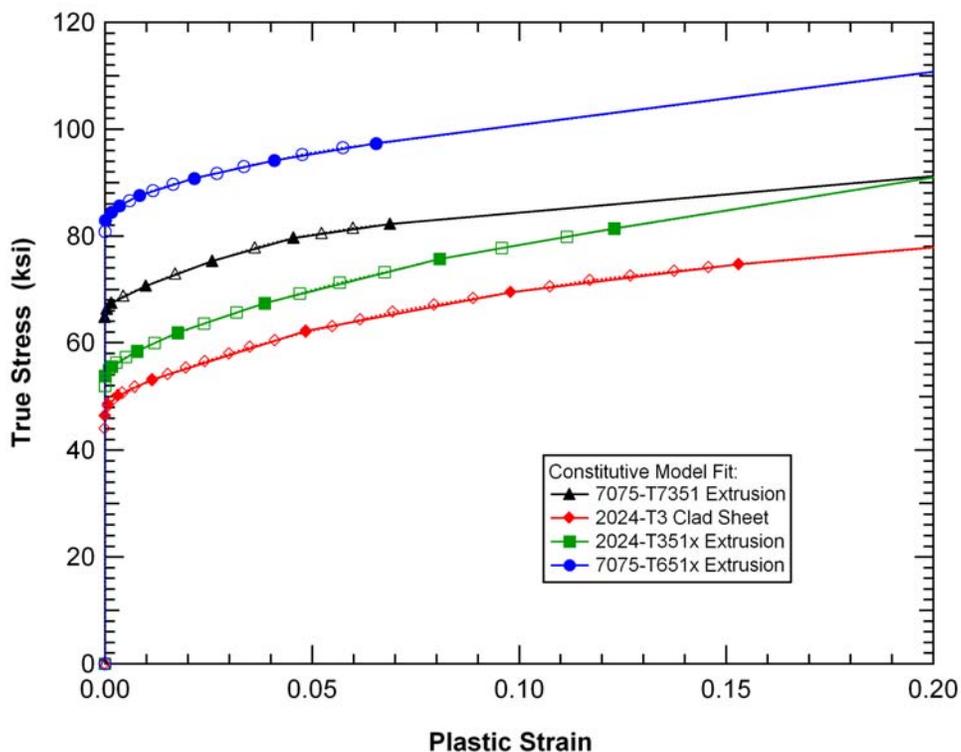
Figure E-6. True stress-strain curves developed for various aircraft aluminum alloys.

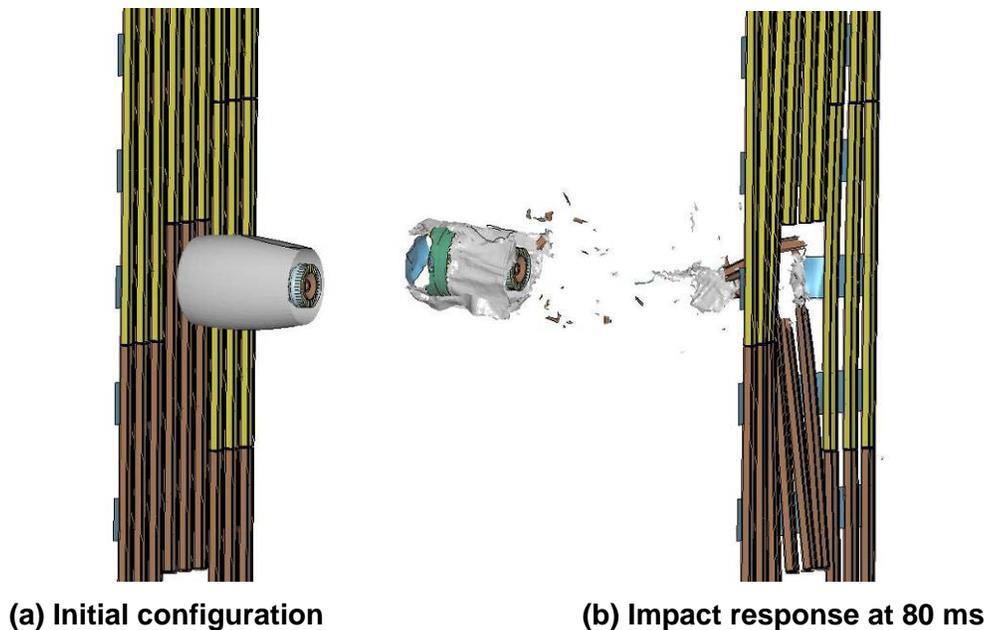
Figure E-15. Example engine impact analysis with exterior columns.

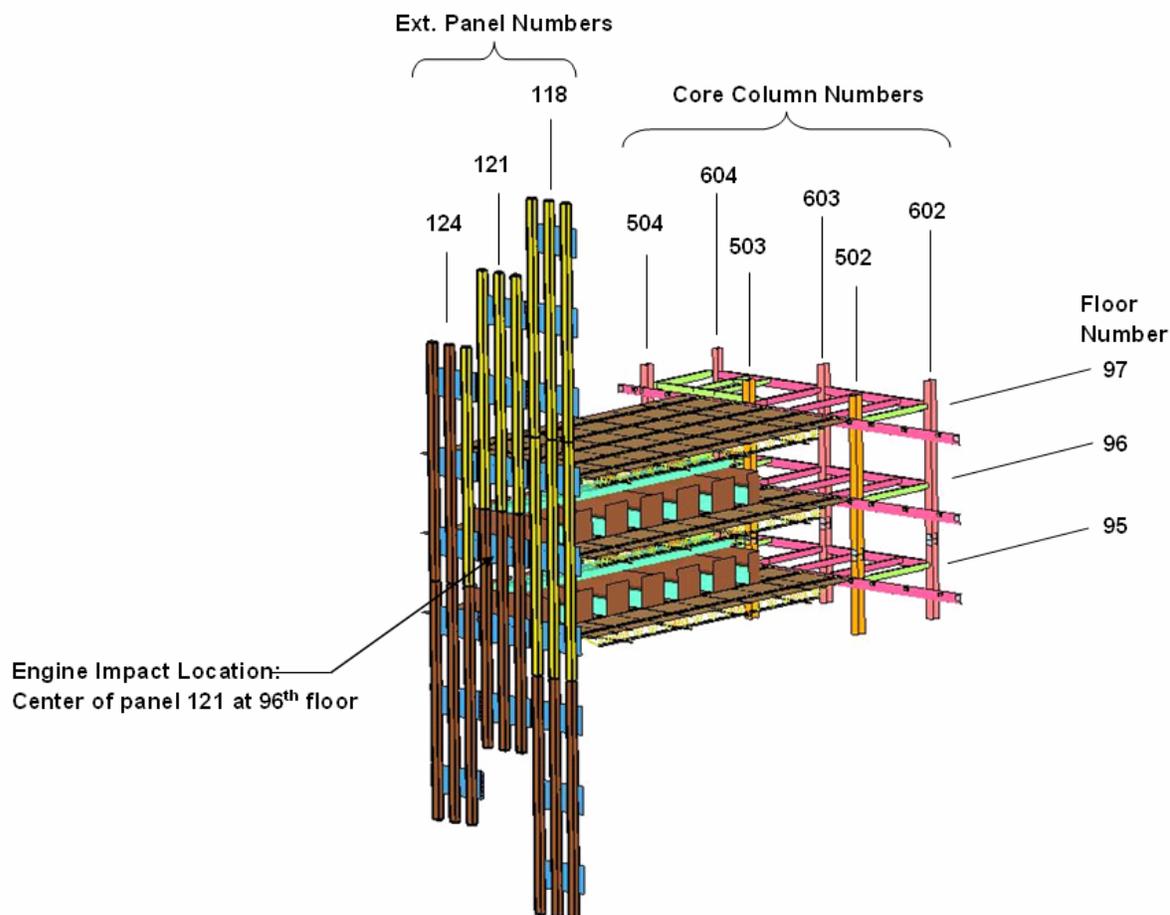
The subassembly analyses were used as a transition between the component level analyses and the global impact analyses. With the subassembly analyses, more complex structural behavior not captured in the component analyses could be investigated with significantly shorter run times than required for the global analyses. The subassembly analyses were primarily used to investigate different modeling techniques and associated model size, run times, numerical stability, and impact response. The final subassembly model used structural components from the impact zone on the north face of WTC 1. The structural components in the final subassembly model included the exterior panels, core framing, truss floor structures, and interior contents (workstations), Figure E–18.

Figure E-18. Final WTC tower subassembly model.

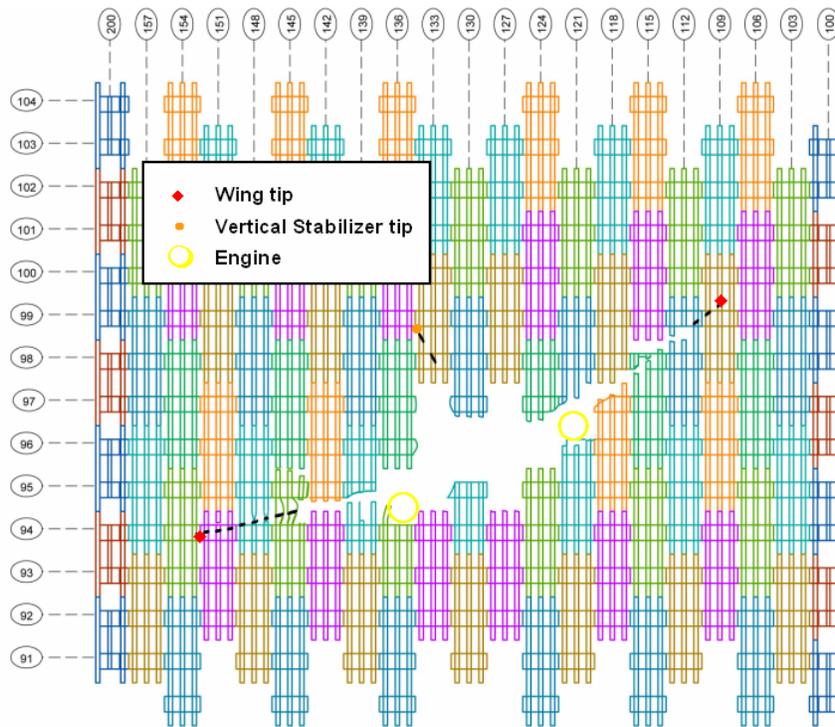
The aircraft impact conditions matching the observed exterior wall damage are shown in Figure E-22 and Figure E-23 for WTC 1 and WTC 2, respectively. The aircraft and exterior wall models were used to visualize the impact scenario in the figures, and the view shown was aligned with the aircraft trajectory. Matching the projected impact points of the wings, fuselage, engines, and vertical stabilizer onto the exterior wall of each tower to the observed damage pattern was an important constraint in the determination of impact conditions. The final set of impact conditions from the analyses are summarized in Table E-3.

Figure E-22. WTC 1 impact damage and impact conditions.

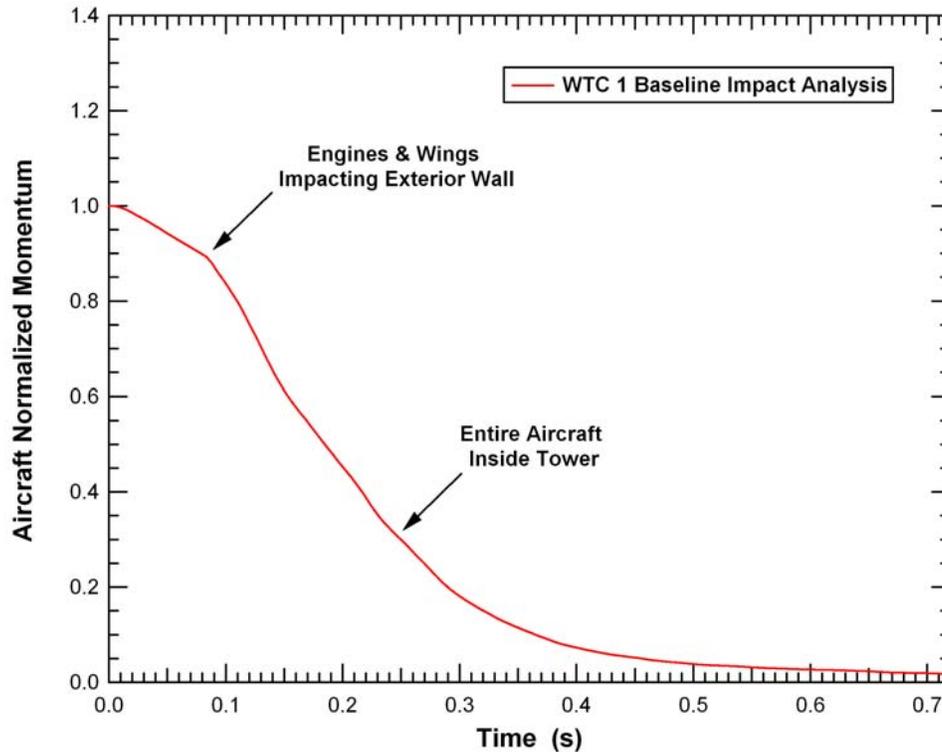
Load transfer of the aircraft momentum into the tower structure is shown in Figure E-27. The momentum plotted was for all of the aircraft structures and contents (including fuel) and was normalized by the initial momentum magnitude. During the first 0.1 s of impact, the forward fuselage penetrated the exterior wall and impacted the interior structures. Between 0.1 s and 0.25 s a more rapid load transfer rate was observed as the area of the impact was larger (extending outward in the wing impact regions) and a higher percentage of the aircraft mass was impacting the interior structures. At 0.25 s, as indicated in Figure E-27, the aircraft completely penetrated the building and retained approximately 30 percent of its initial momentum. Beyond this time, the rate of load transfer steadily decreased with very little load transfer after approximately 0.5 s.

Figure E-27. Normalized aircraft momentum for the WTC 1 base case impact.

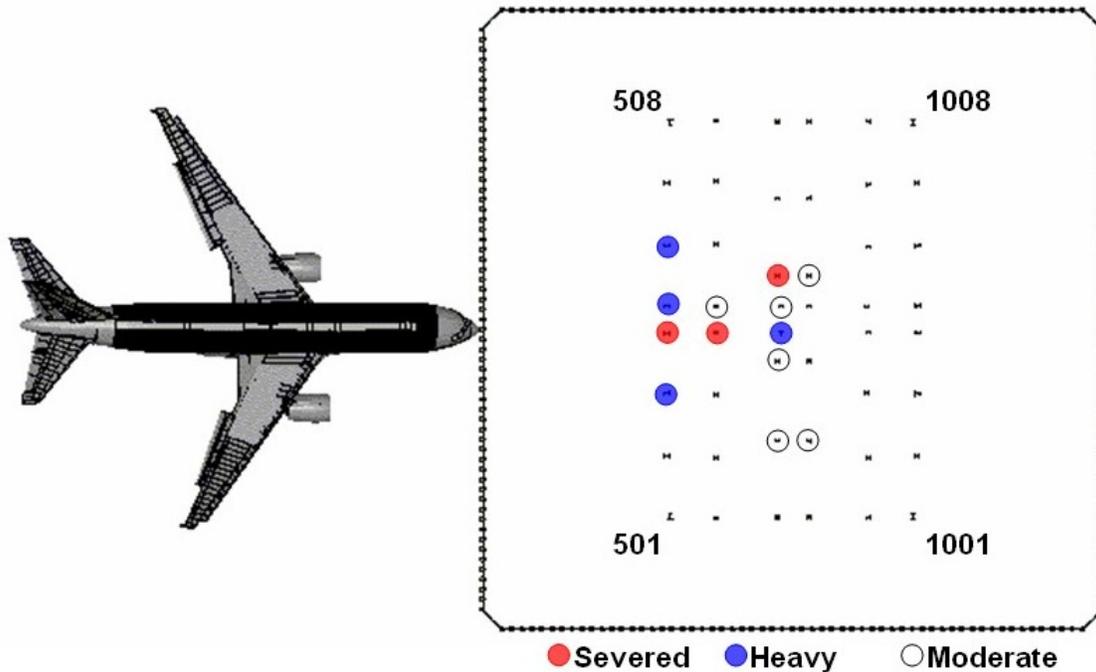
A summary of the column damage is shown graphically in Figure E-31. The damage classification levels shown in the figure are light damage, moderate damage, heavy damage, and failed (severed). The light damage level was defined as showing evidence of impact (low level plastic strains), but without significant structural deformations. The moderate damage level had visible local distortions of the column cross section (e.g., bending in a flange), but no lateral displacements of the column centerline. The heavy damage classification was for impacts that produced global deformation of the column, resulting in a permanent deflection of the column centerline. The severed columns were completely failed and could carry no residual load. The calculated damage to the core of WTC 1 consisted of three severed columns and four heavily damaged columns.

Figure E-31. Core column damage for the base case WTC 1 impact.

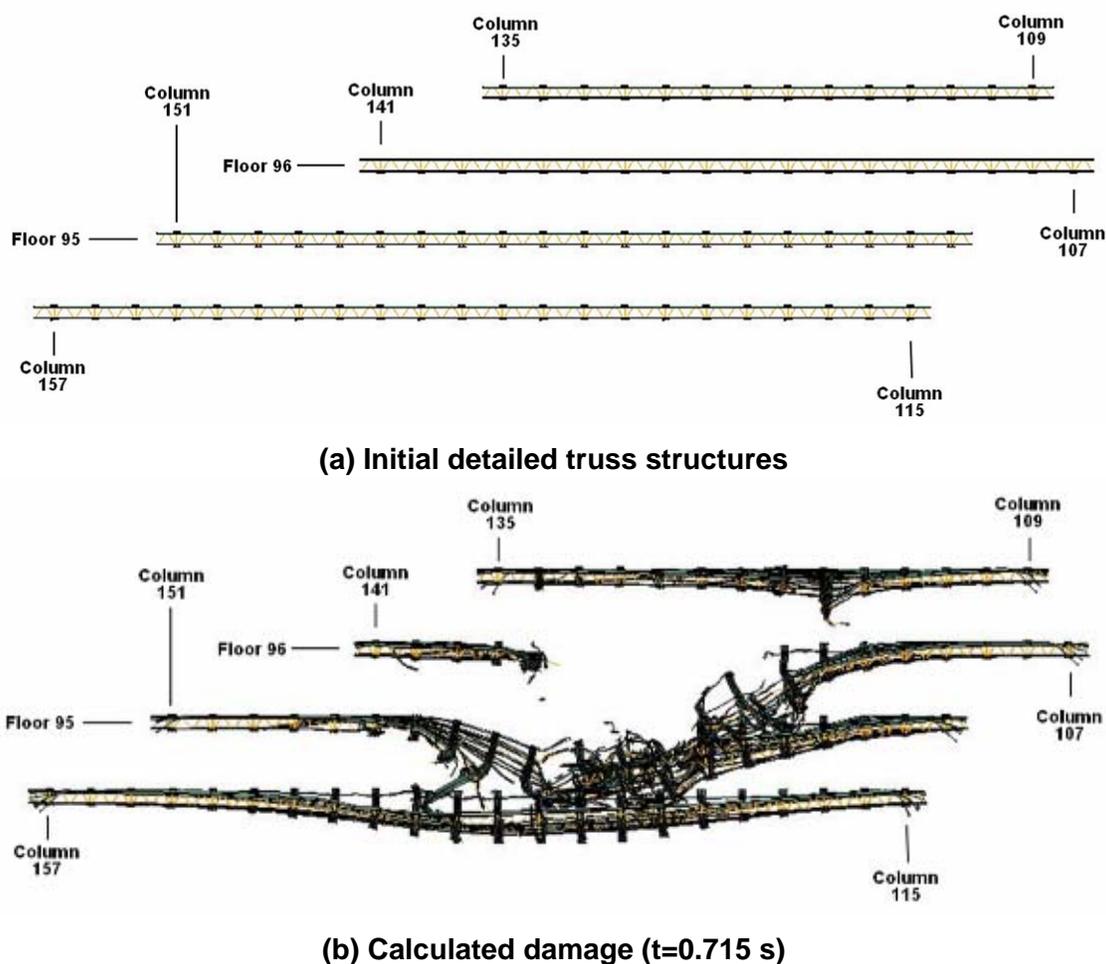
An overall view of the floor truss structure in the impact zone, along with the calculated impact damage to the floor trusses, is shown in Figure E-32. The figure shows that the trusses experienced significant damage in the impact zone. The calculated impact response produced severe damage to the truss structures in the primary impact path of the fuselage. The truss structures were severely damaged from the exterior wall to the core. The truss floor system on floors 94 through 96 were damaged and sagging downward as a result of the impact loading.

Figure E-32. Base case impact damage to the WTC 1 floor truss (front view).

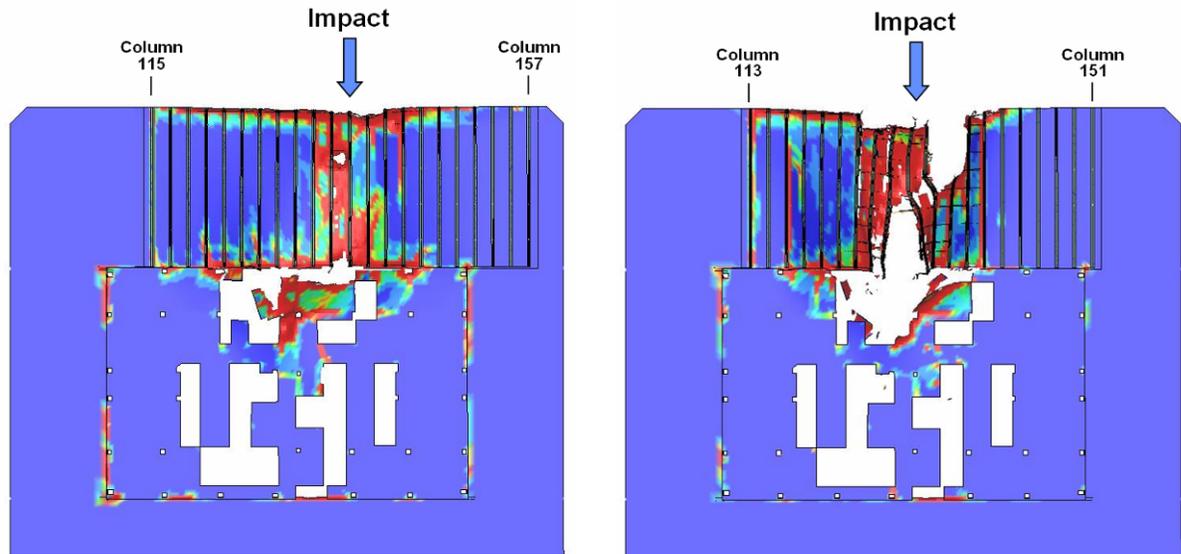
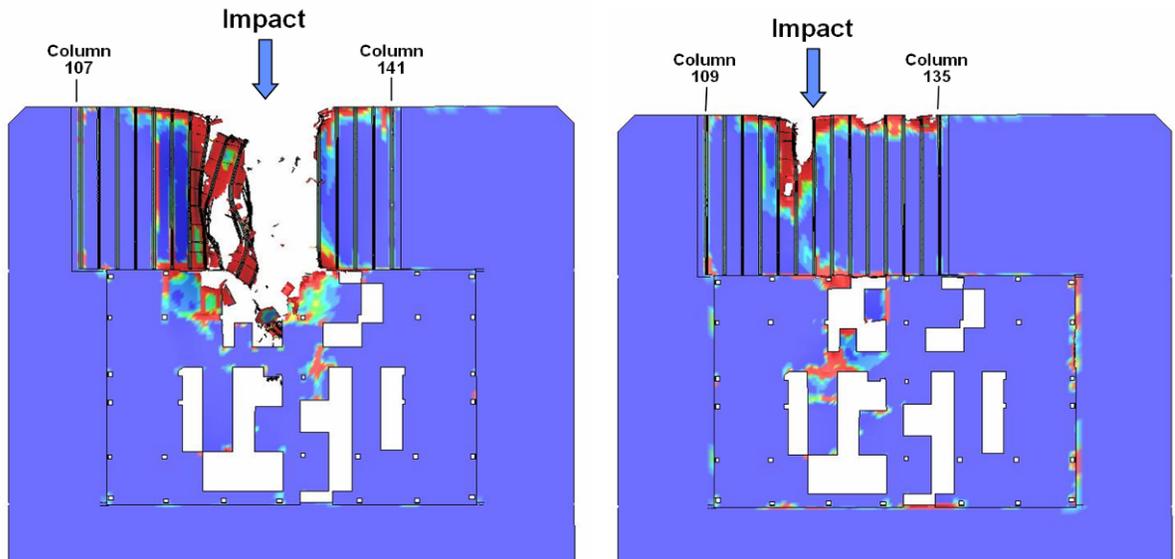
After concrete failure, break up, and removal, the strength of the floor slab was severely reduced in the analyses to model the residual strength of the metal deck. At a plastic strain of 30 percent, corresponding to failure levels for the metal decking material, the elements were eroded (seen as holes ruptured in the floor slabs shown). Figure E-33 shows that the truss floor and associated slab were heavily damaged or completely destroyed in the impact zone. The zone of heavy damage to the floor slab extended beyond the truss floor and was approximately one-third of the distance through the core on floors 94 through 96.

(a) Floor 94 slab damage

(b) Floor 95 slab damage

(c) Floor 96 slab damage

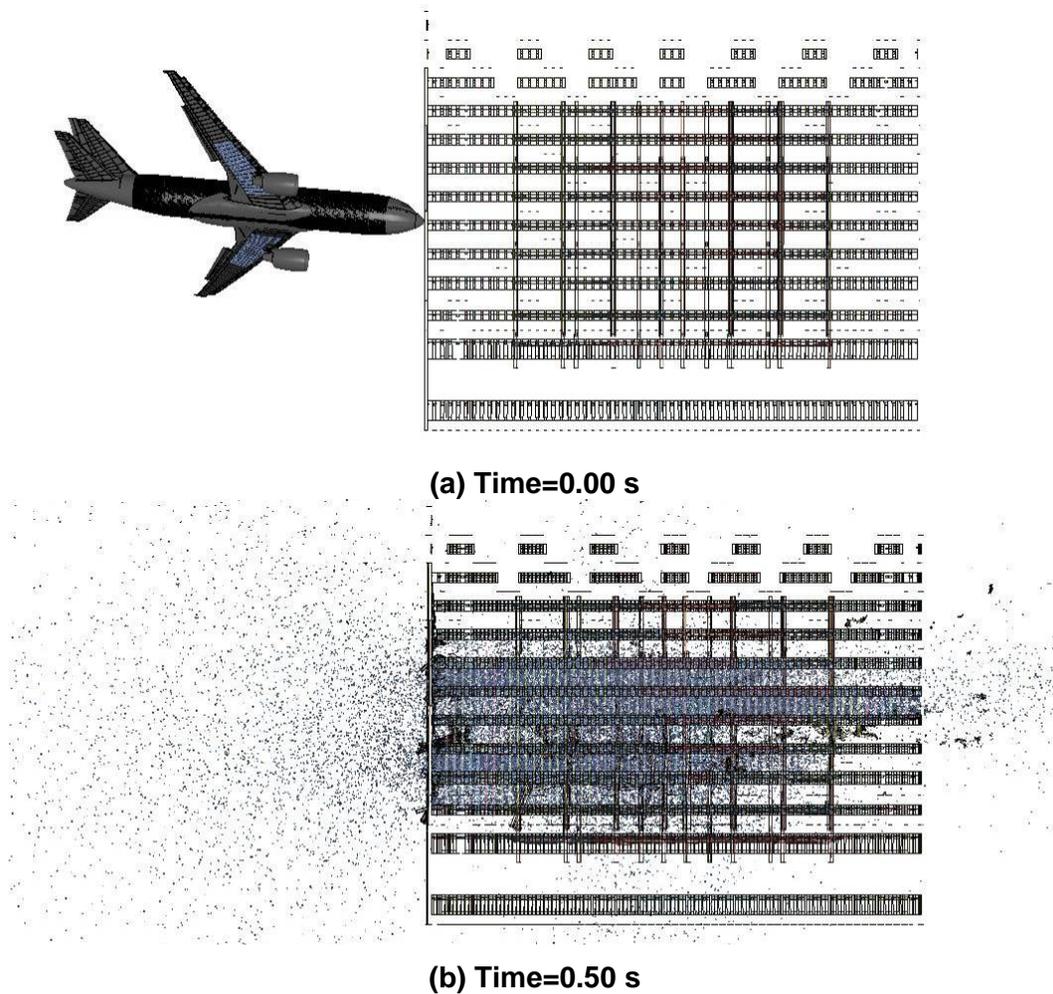
The WTC 2 base case impact analysis was performed for a 0.62 s duration following initial impact of the aircraft nose with the south exterior wall. The side view and top view of the base case WTC 2 global impact response is shown in Figure E–34 and Figure E–35, respectively. Full penetration of the aircraft into the tower was completed at 0.2 s after impact. The aircraft impact response was very similar to that of the WTC 1 impact and was dominated by the penetration and fragmentation of the airframe structures. The fuselage structures were severely damaged both from the penetration through the exterior columns and the penetration of the 81st floor slab that sliced the fuselage structures in half. The downward trajectory of the aircraft structures caused the airframe to collapse against the floor, and the subsequent debris motion was redirected inward along a more horizontal trajectory parallel to the floor. The downward trajectory of the aircraft structures had transferred sufficient vertical load that the truss floor structures on the 80th and 81st floors began to collapse in the impact zone by the end of the simulation.

Figure E-34. WTC 2 base case global impact analysis – side view.

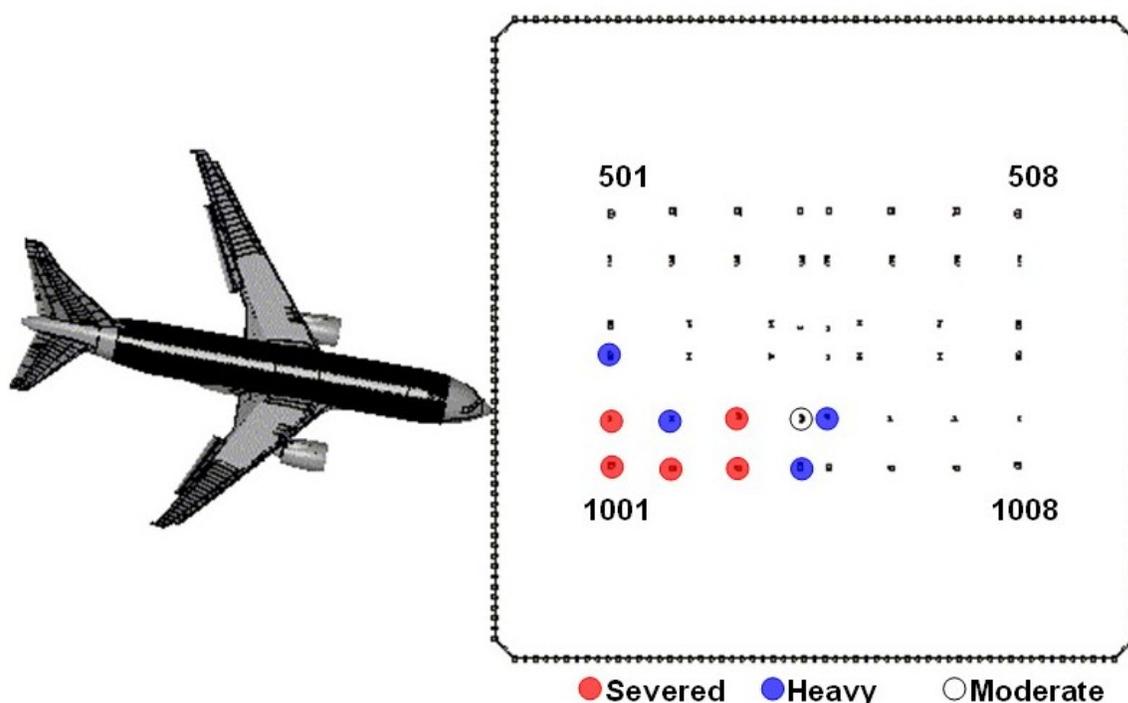
In the base case WTC 2 impact damage analysis, significant damage to the core was calculated in the region close to the impact point (the south east corner of the core). The columns in line with the aircraft fuselage failed on the impact side of the tower and several of the core beams were also severely damaged or failed in the impact zone. In some cases, failure of the column splices located on floors 77, 80, and 83 contributed significantly to the failure of the core columns. This was particularly true for the heavy column number 1001 at the southeast corner of the core that failed at three splice locations. A summary of the column damage is shown graphically in Figure E-39. A total of five columns were severed and four columns were heavily damaged.

Figure E-39. Summary of core column damage for the base case WTC 2 impact.

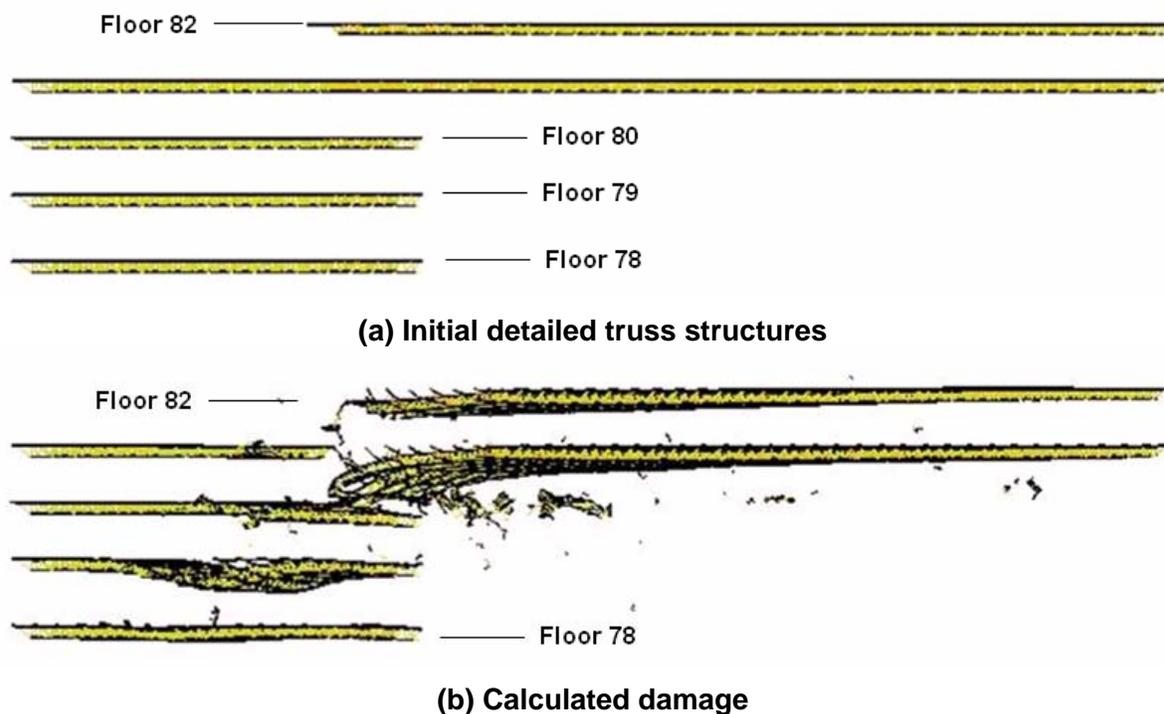
angle directed more impact energy normal to the floor slab. The vertical component of the impact load in WTC 1 was approximately 40 percent higher than in WTC 2. The secondary factor was that the damage to the long span truss floor in the WTC 1 impact zone produced larger displacements than the corresponding damage to the short span truss region in WTC 2.

Figure E-40. Base case impact damage to the WTC 2 floor truss (front view).

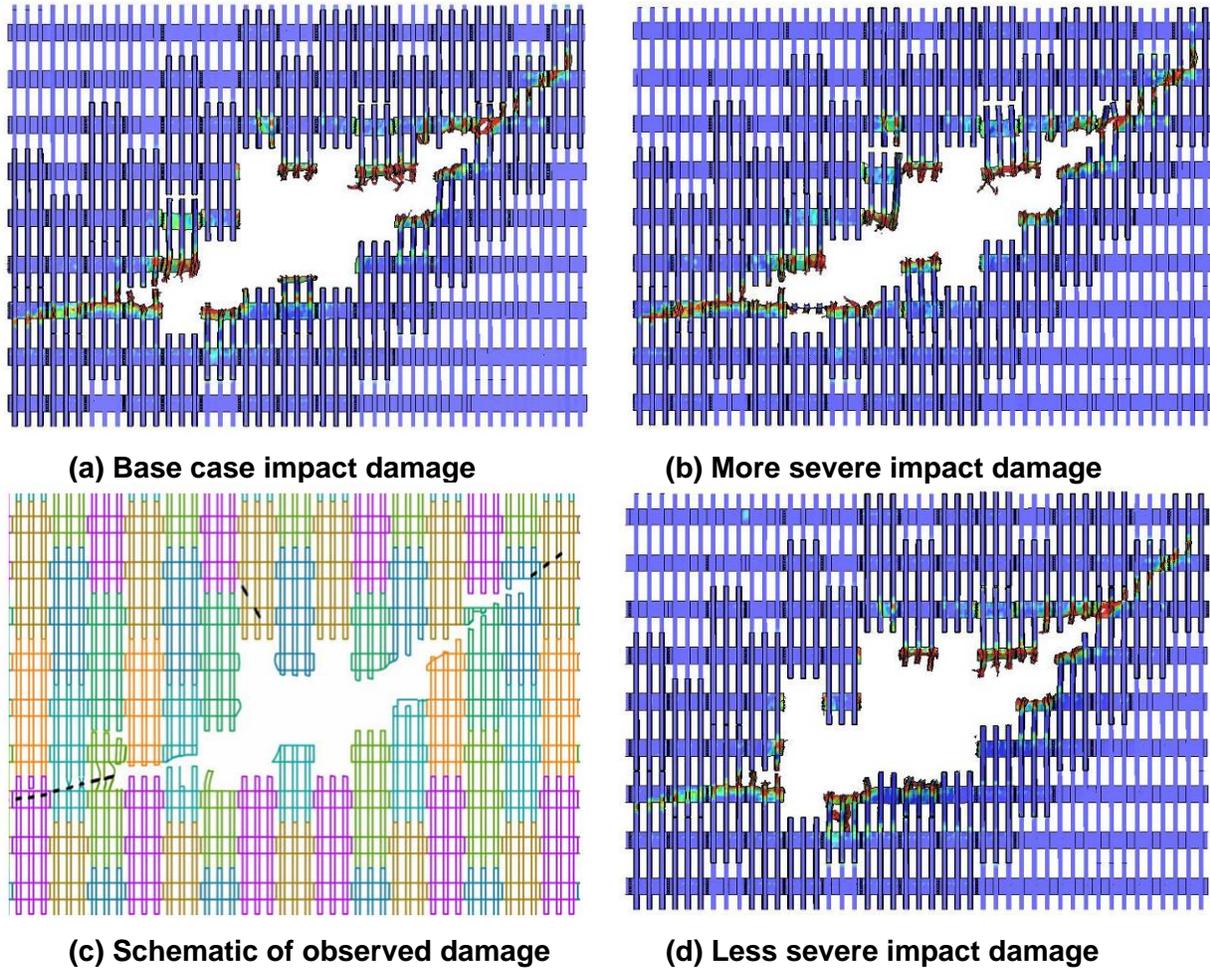
Figure E-41. Comparison of exterior wall damage for the WTC 1 impact analyses.

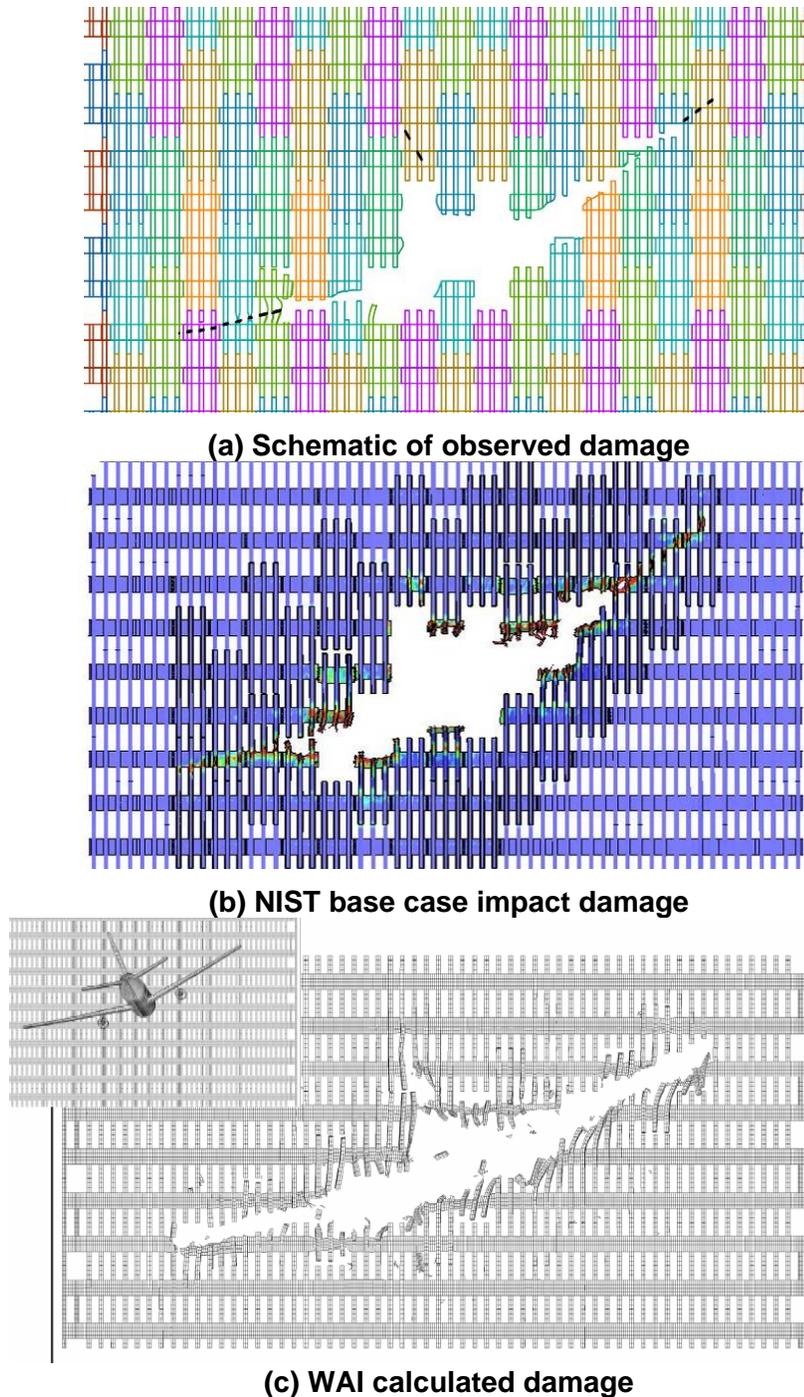
The differences in the damage profiles in the two calculations most likely resulted from a variety of differences in the models. One major difference between the two studies was in the fidelity of the aircraft models. The WAI aircraft model was based on their model of a Lockheed C-141B military transport rather than the Boeing 767. The NIST aircraft model contained an order of magnitude more elements and modeled the fuel explicitly. Secondary differences between the WAI and NIST impact analyses included, but were not limited to, variations in impact conditions (impact velocity, angle, location, etc.), aircraft model differences (airframe geometry, component thicknesses, mass distribution, material properties, etc.) and tower model differences (material properties, geometry, joint modeling, number of elements, etc.).

Figure E-44. Comparison of impact damage to the WTC 1 exterior wall.

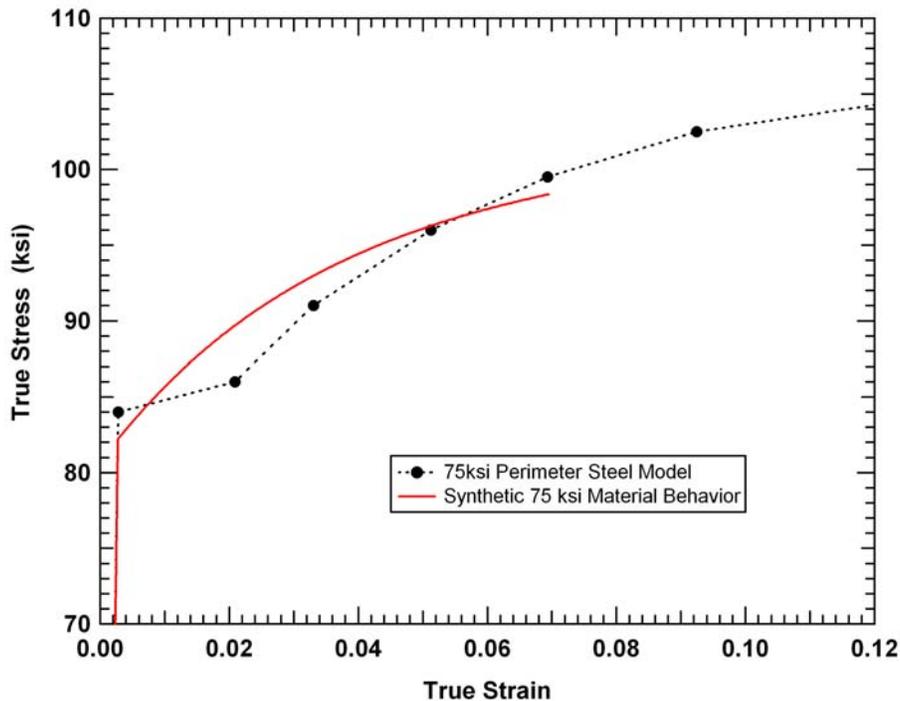
test data were used as the input for the material modeling to provide validated stress-strain properties up to failure. A comparison of this synthetic curve with the constitutive model behavior for the 75 ksi steel is shown in Figure 2–7. There were observable differences in the curves, such as the representation of a yield point behavior in the constitutive model. However, the differences were not sufficiently large to produce a large variation in the calculated structural impact behavior. In addition, the effect of material strength variation on impact damage was assessed in the uncertainty analyses.

Figure 2–7. Comparison of the constitutive model and synthetic steel behaviors for the 75 ksi steel.

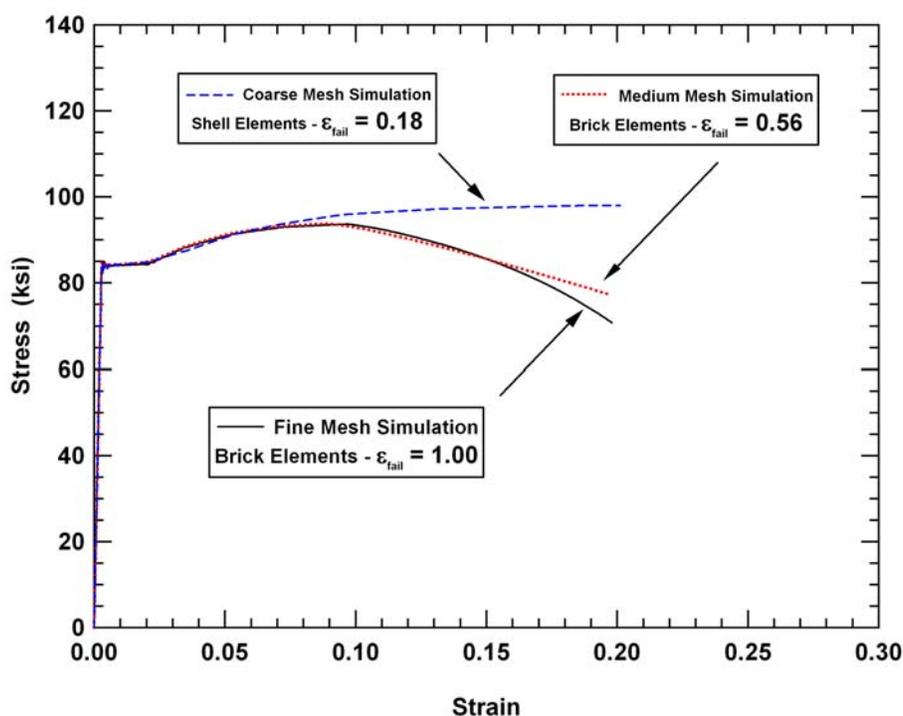
Figure 2–15. Mesh refinement effects in the calculated 75 ksi tensile test.

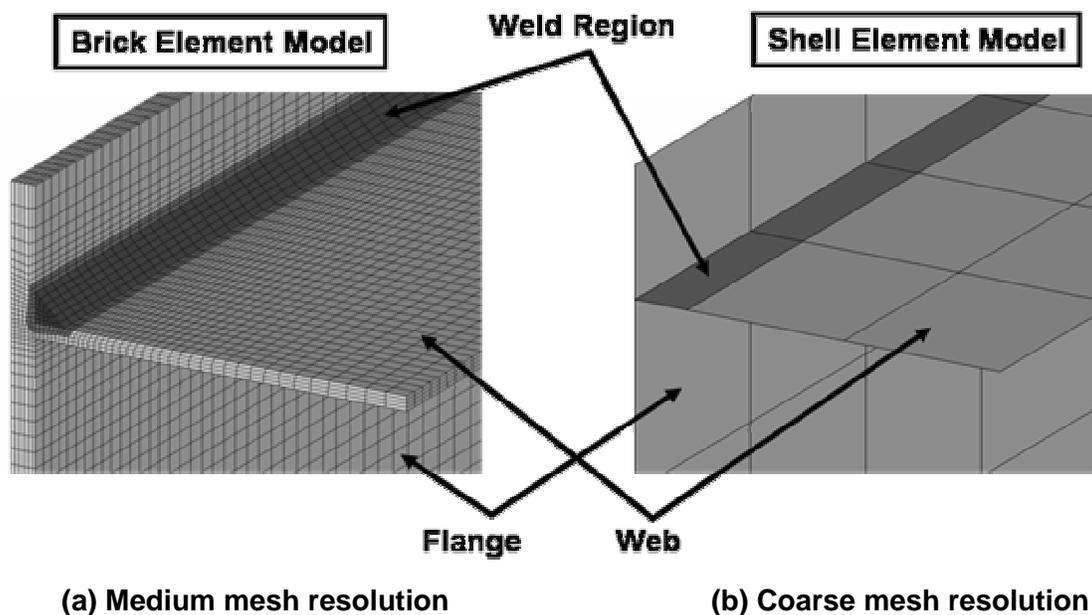
An average critical strain of approximately one-quarter of that in the corresponding base metal was selected for the 1 in. wide single shell element weld zone. This weld zone failure strain was 8 percent in the current example (55 ksi steel). The comparison of the resulting impact behavior for the brick and shell element models is shown in Figure 2–22. Both models had similar impact deformations, and the length of the weld failures were in good agreement. These analyses provided an upper bound value for the engineering fracture criteria in the weld region. Additional investigation of the weld failure and the effects of a more brittle fracture response were investigated in the subassembly analyses (Section 6.3.2). These subassembly impact analyses demonstrated that the weld zone fracture criterion had a negligible effect on the impact energy absorption and little significance on the impact damage.

Figure 2–20. Models developed for column weld fracture analysis.

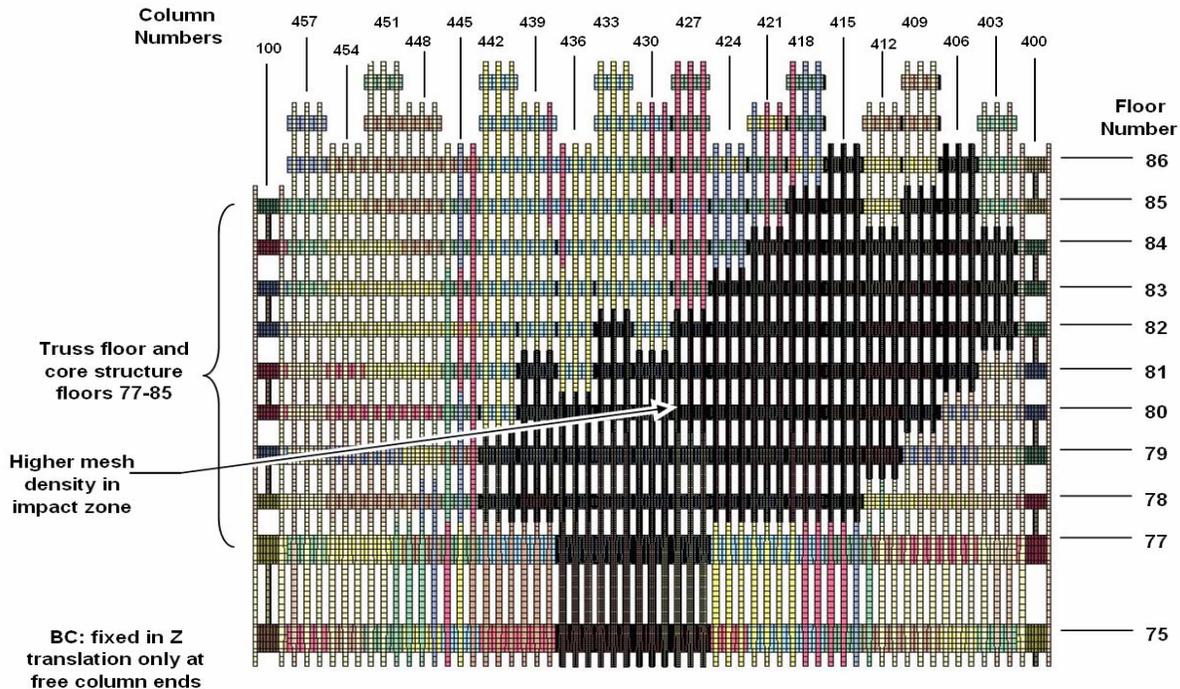
Figure 3-11. Impact face of the WTC 2 model - floors 75-86.

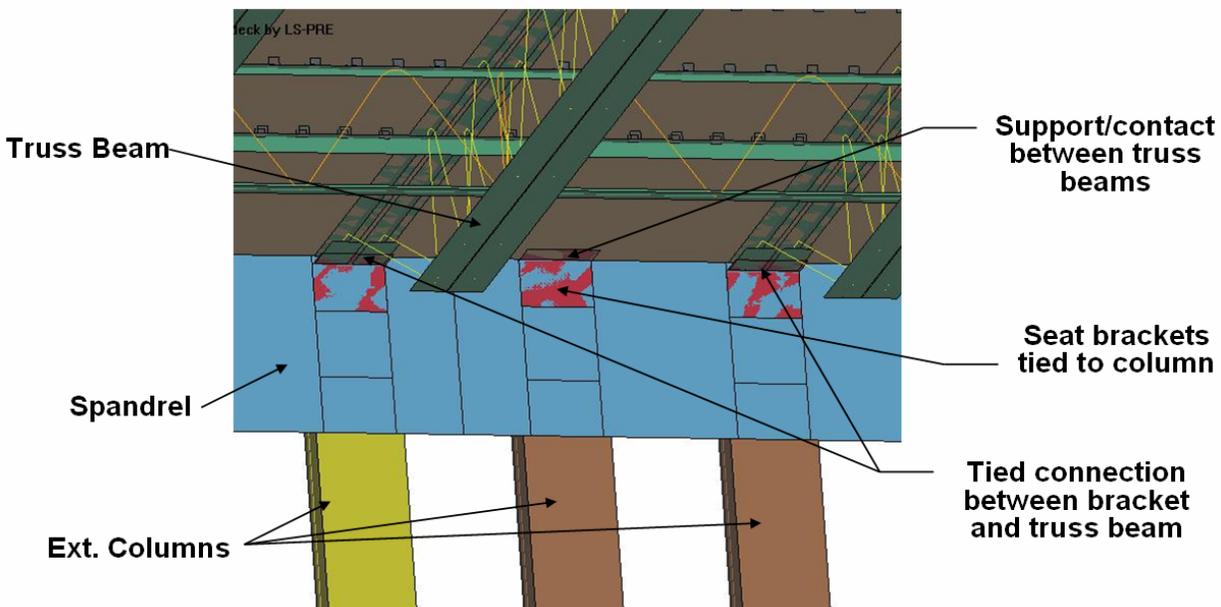
Figure 3–15 and Figure 3–16 show truss floor connection details at the exterior wall and core, respectively. The models for the truss seat connections were developed using shell elements and attached using the tied interface algorithm. The failure of the seats only occurs as a result of exceeding the ductility of the seat or truss structures.

Figure 3–15. Truss floor connection detail at exterior wall.

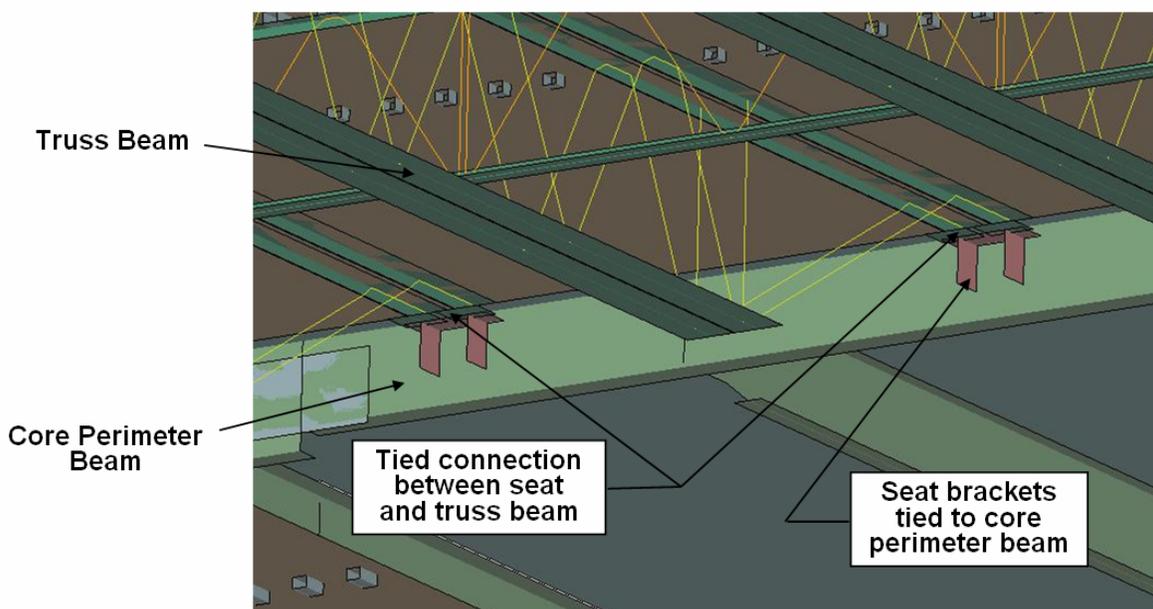
Figure 3–16. Truss floor connection detail at core perimeter.

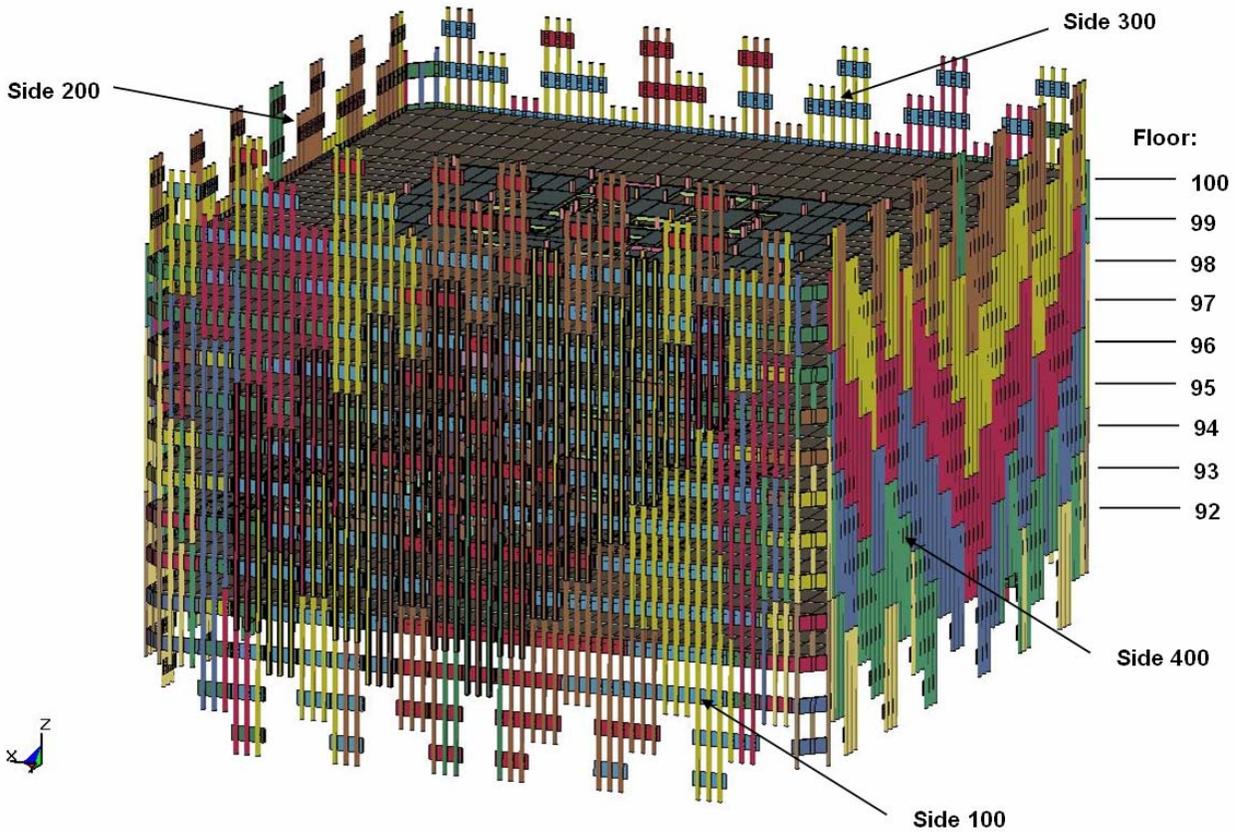
Figure 3–21. Multi-floor global impact model of the WTC 1 tower.

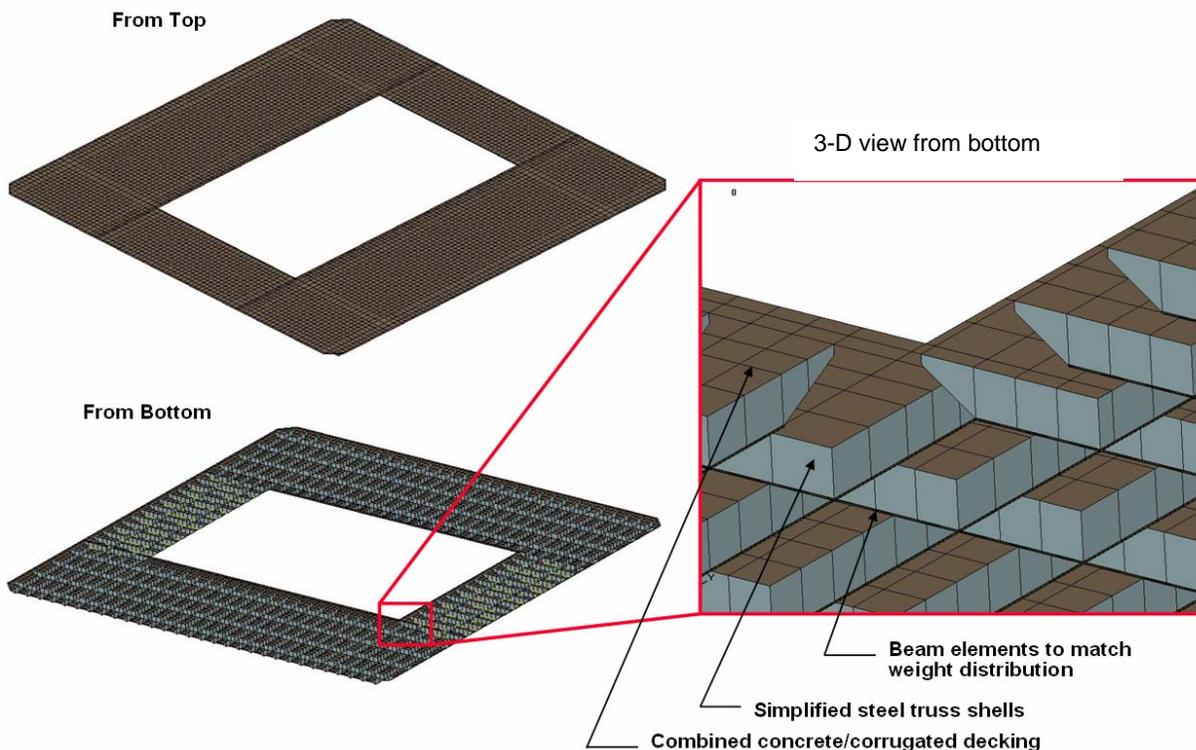
Figure 3–25. Far field truss floor model in the WTC towers.

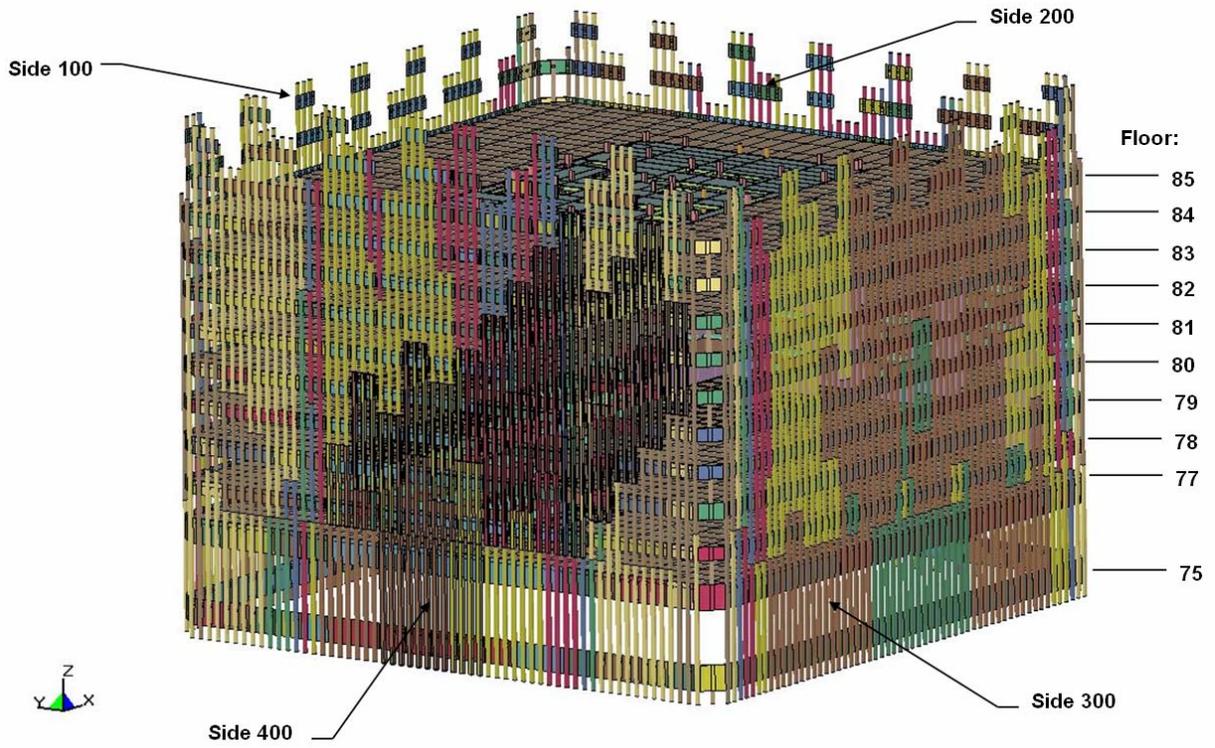
To summarize, the approach adapted for the development of the global impact models for towers WTC 1 and WTC 2 was similar. The structures were modeled primarily with shell elements with some beam elements in the detailed truss floor sections and bolted connections between the column ends in the impact zone of the exterior wall. Some brick elements were used at the exterior column butt plates in the detailed impact zone. A summary of the model size and element types for the global tower models is presented in Table 3–2.

Figure 3–26. Multi-floor global impact model of the WTC 2 tower.

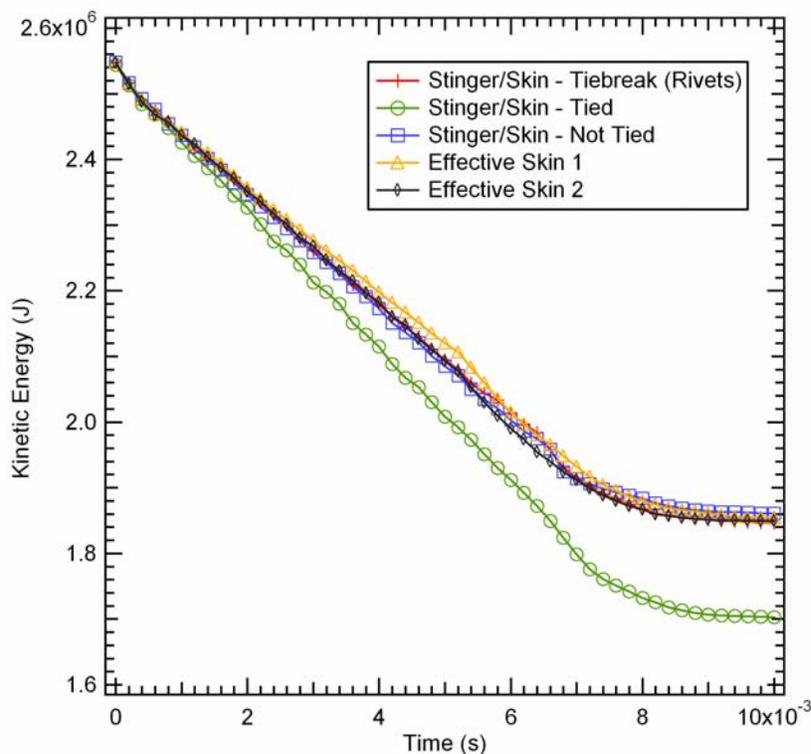
The kinetic energy of the wing segment and the internal energy of the exterior column were used to evaluate the effective skin performance. Yield strengths for each of the effective skins were modified until the residual kinetic energy of the wing segment debris most closely matched that of the model with the stringer/skin construction, as shown in Figure 4–23. Both effective skin options could be made to closely match the kinetic energy of the riveted stringer/skin construction. Also shown in the figure are the results for a tied and unbonded (not tied) stringer/skin construction.

Figure 4–23. Kinetic energy of the wing model.
