NIST NCSTAR 1-2B

**Federal Building and Fire Safety Investigation of the
World Trade Center Disaster**

Analysis of Aircraft Impacts into the World Trade Center Towers

September 2005

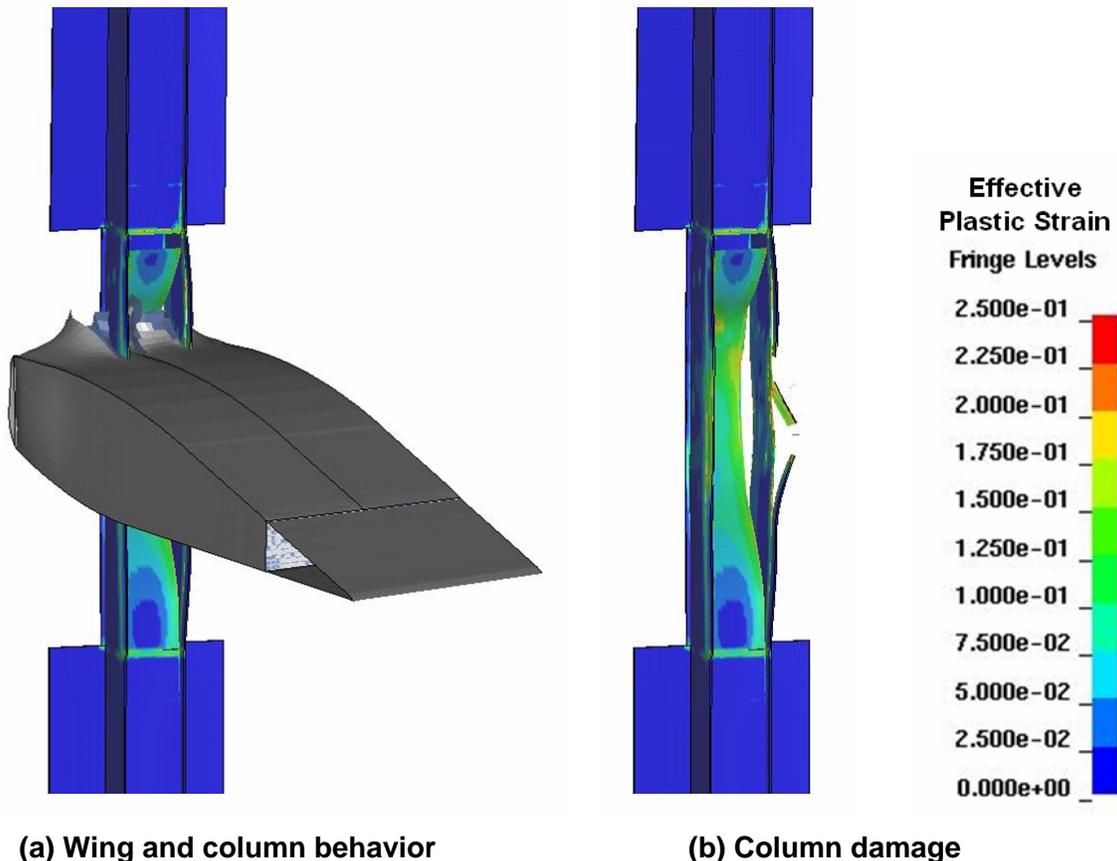
Figure 5–2. Calculated wing with fuel impact response on the exterior column.

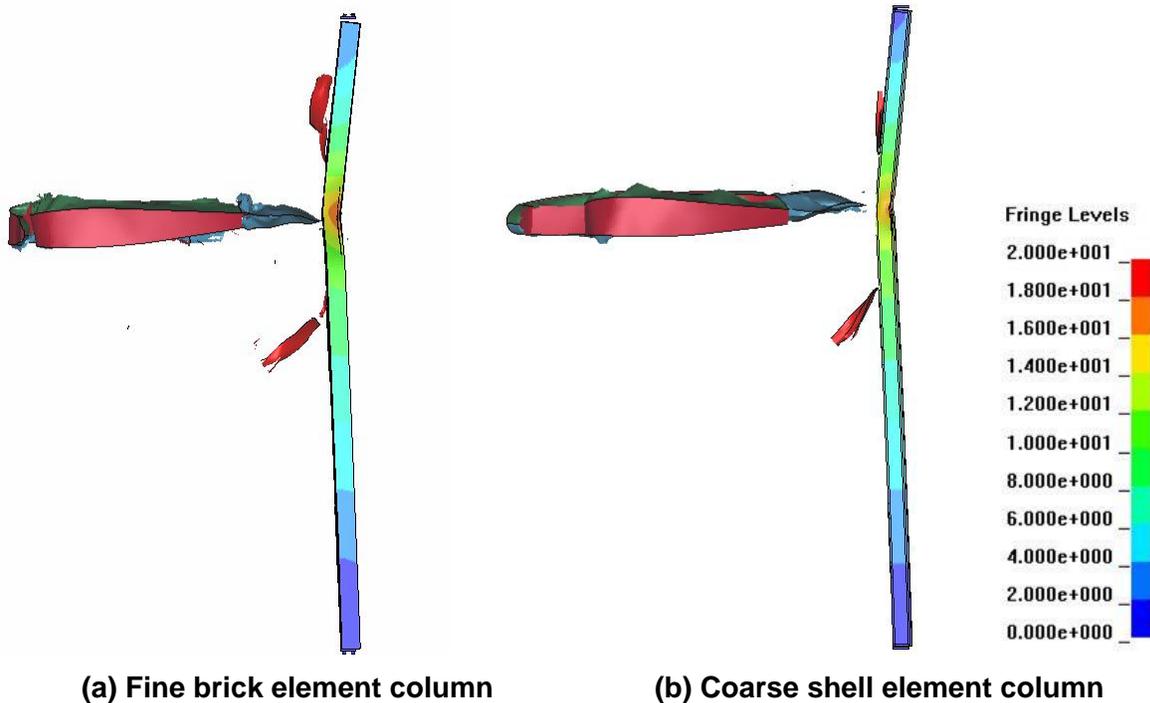
Figure 5–4. Exterior column response comparison, showing contours of the displacement magnitude (inches).

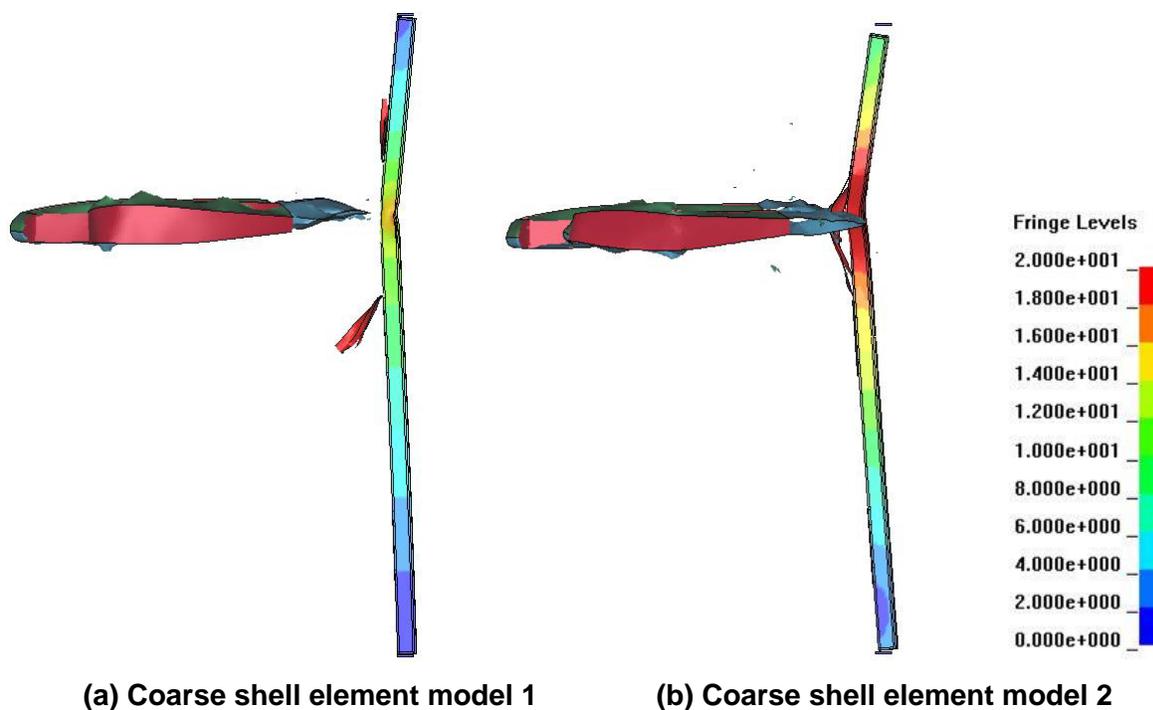
Figure 5–5. Exterior column response comparison, showing contours of the displacement magnitude (inches).

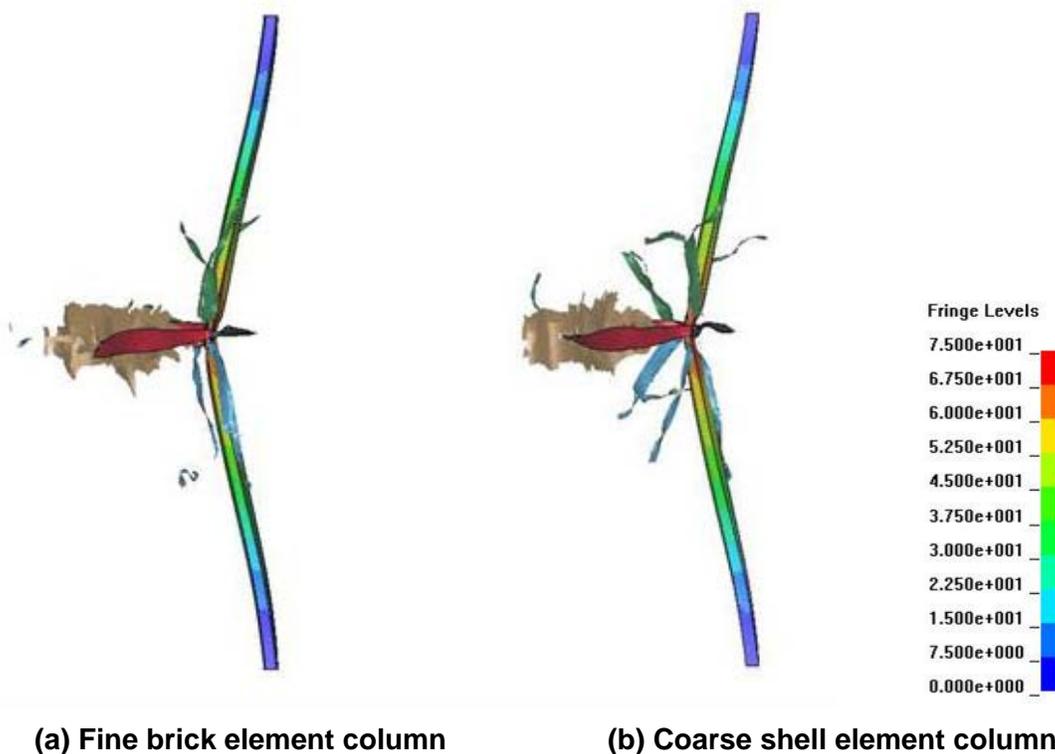
Figure 5–6. Wide flange core column response comparison, showing contours of the displacement magnitude (inches).

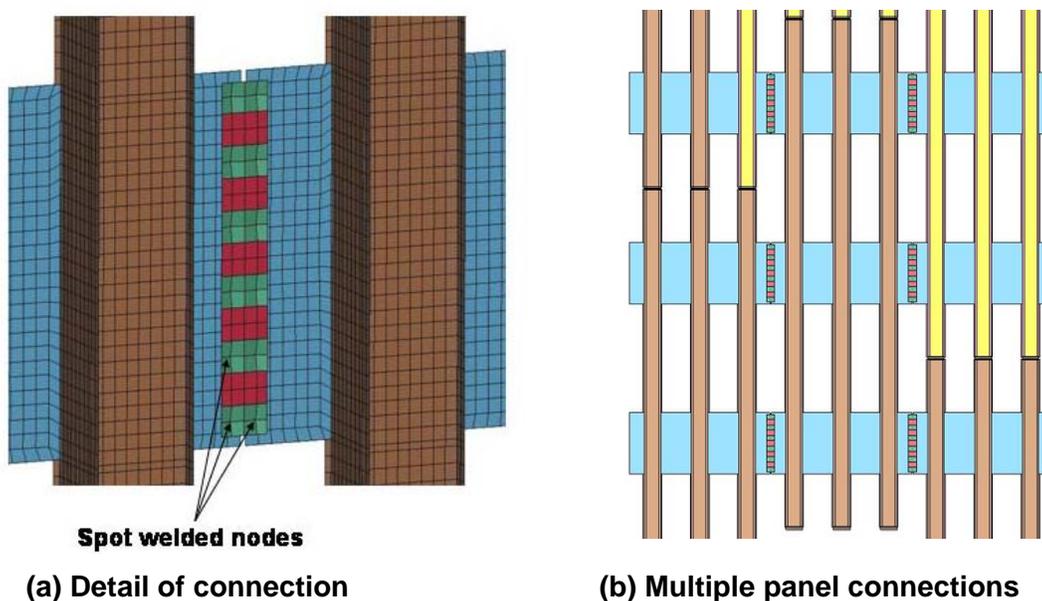
Figure 5–14. Bolted spandrel connection treatments.

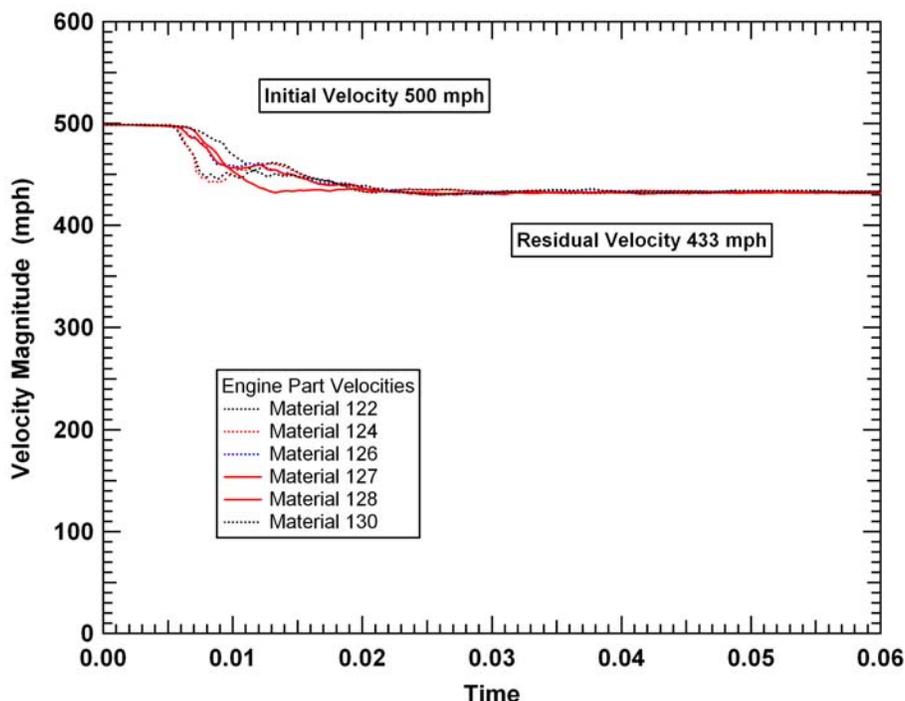
Figure 5–16. Engine velocity history for the exterior wall impact.

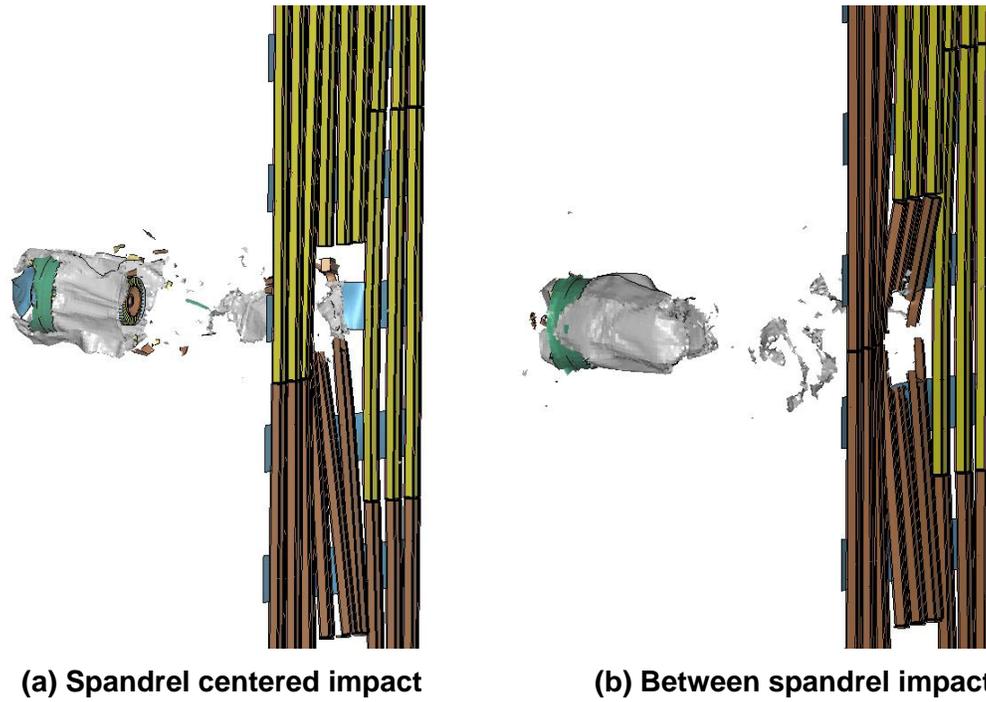
Figure 5-17. Example engine impact analysis with different impact locations.

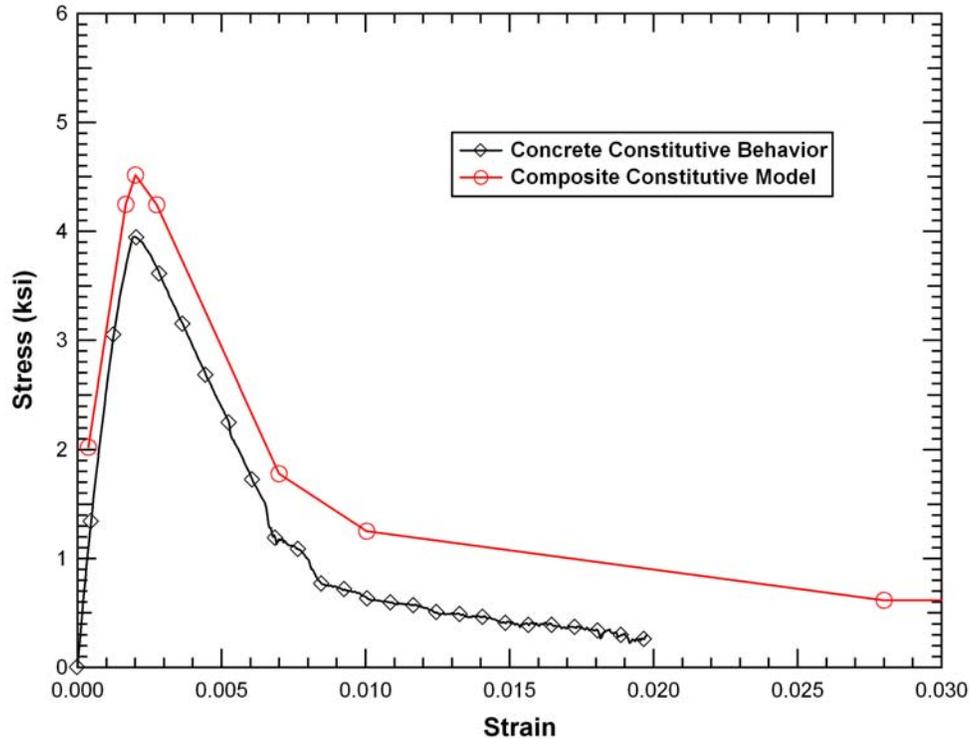
Figure 5–24. Constitutive behavior for the combined concrete and metal decking.

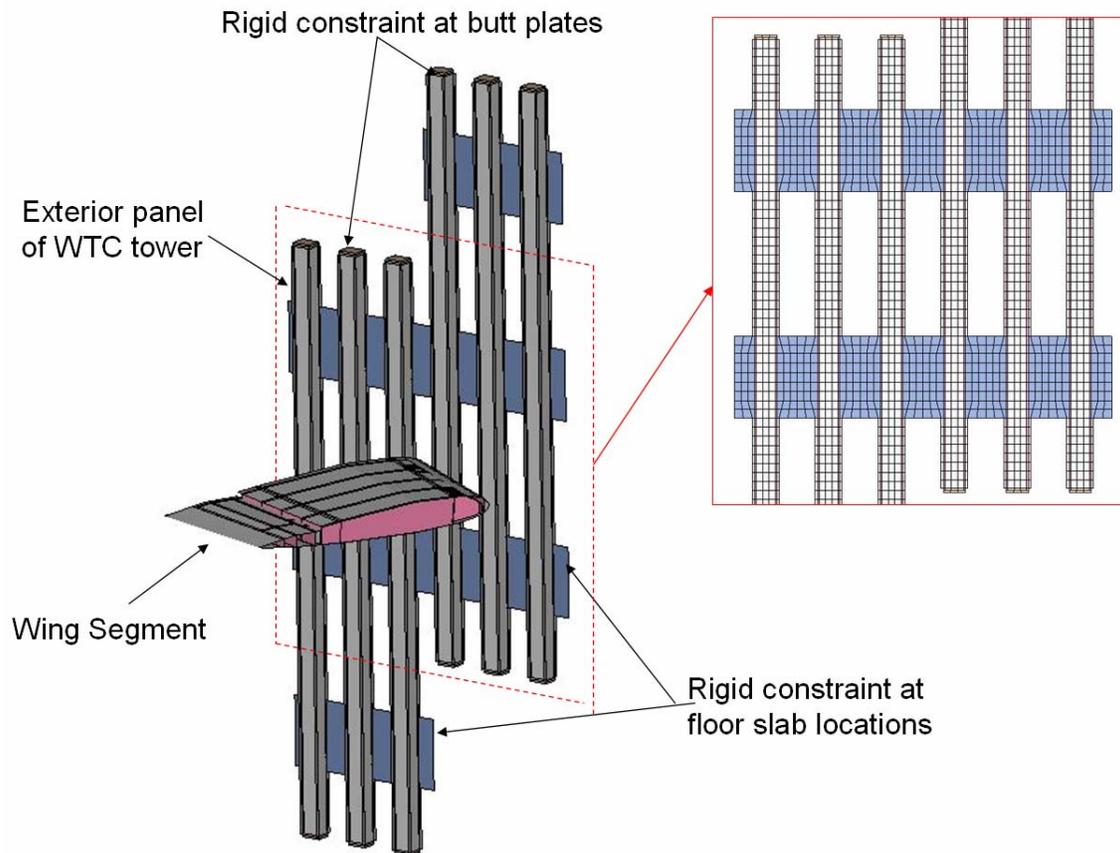
Figure 5–28. Empty wing section impact model with two exterior panels.

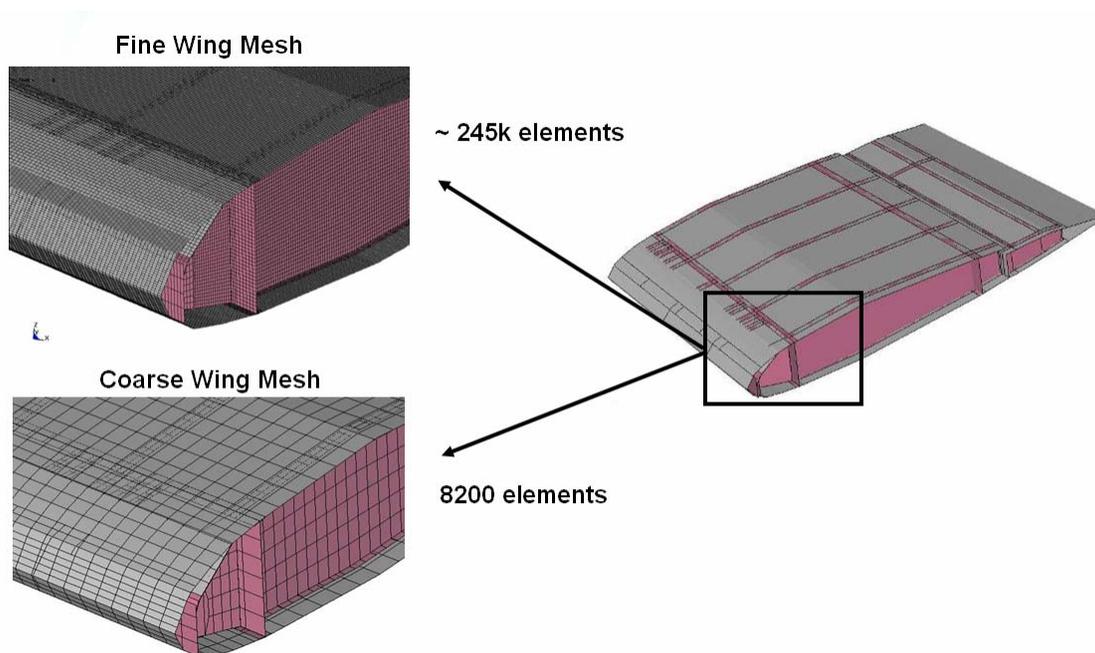
Figure 5–30. Coarse and fine mesh used in the small wing component model.

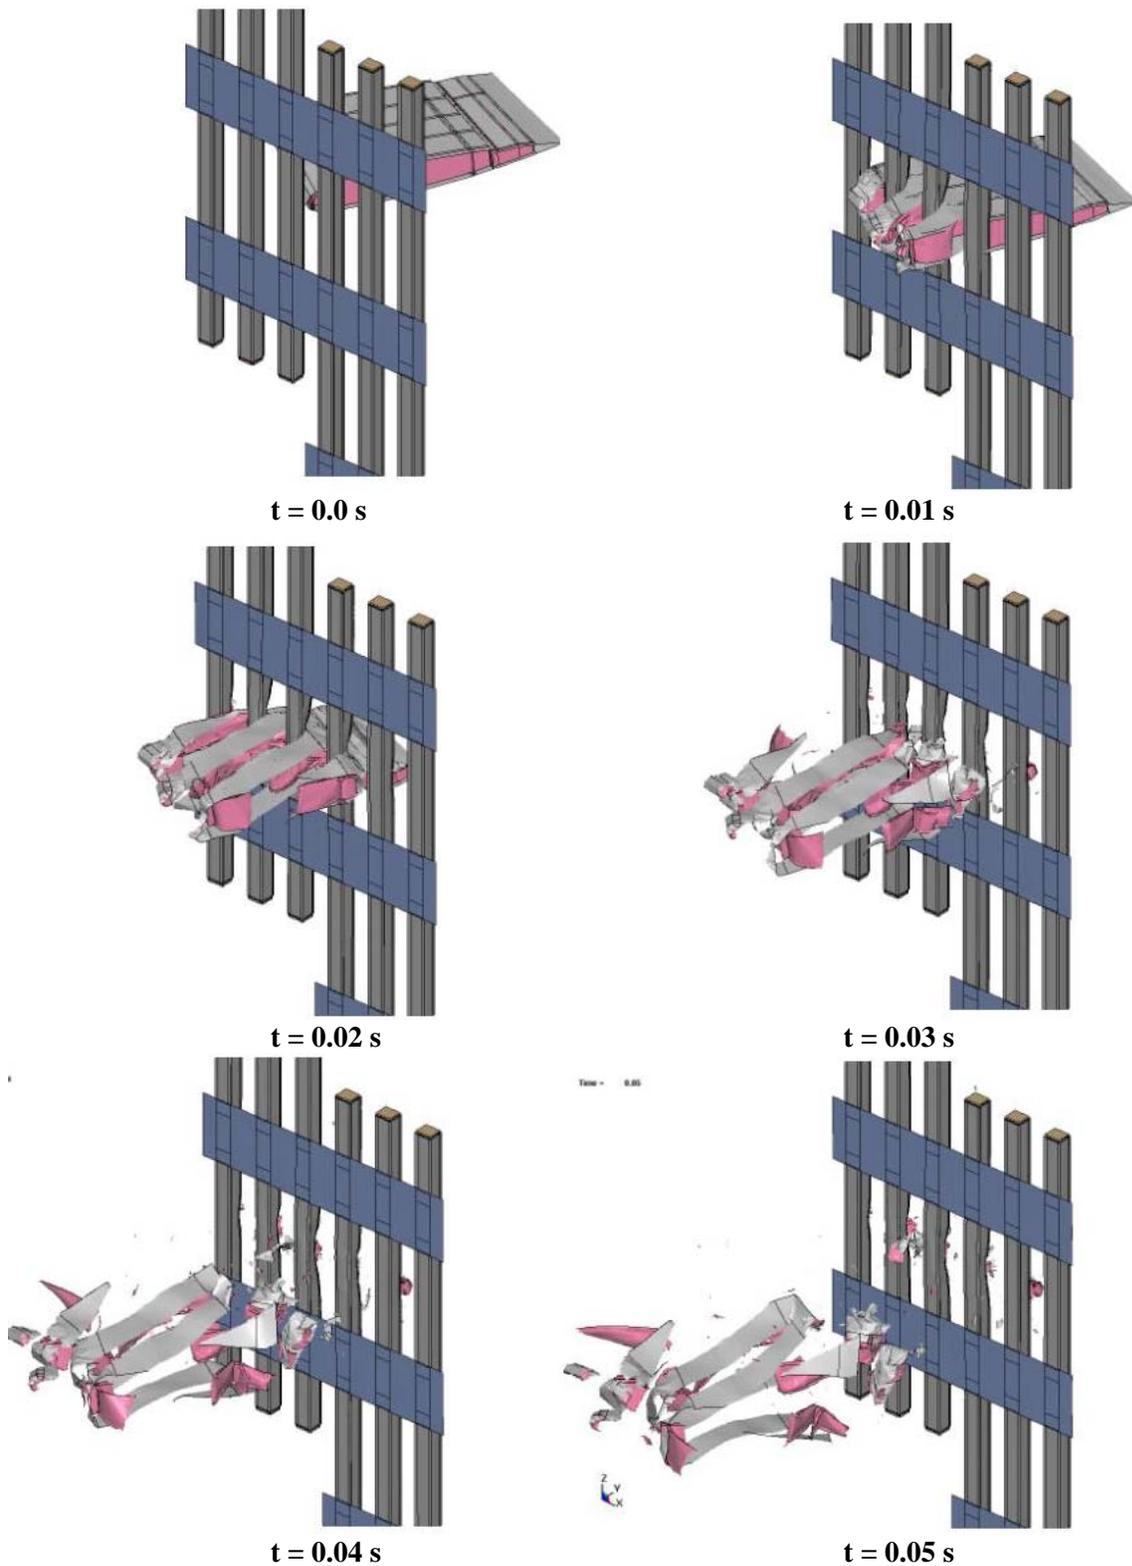
Figure 5–31. Calculated impact of a fine-mesh empty wing section with two exterior panels at 442 mph.

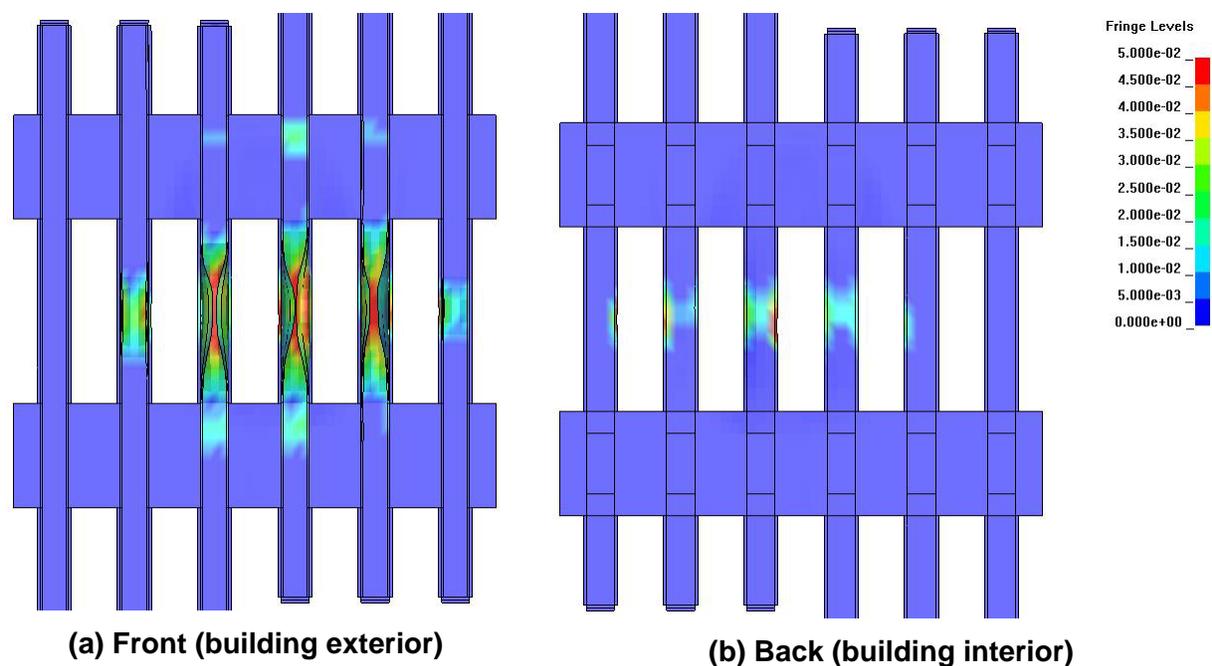
Figure 5–32. Fine-mesh empty wing section impact damage to the exterior panel.

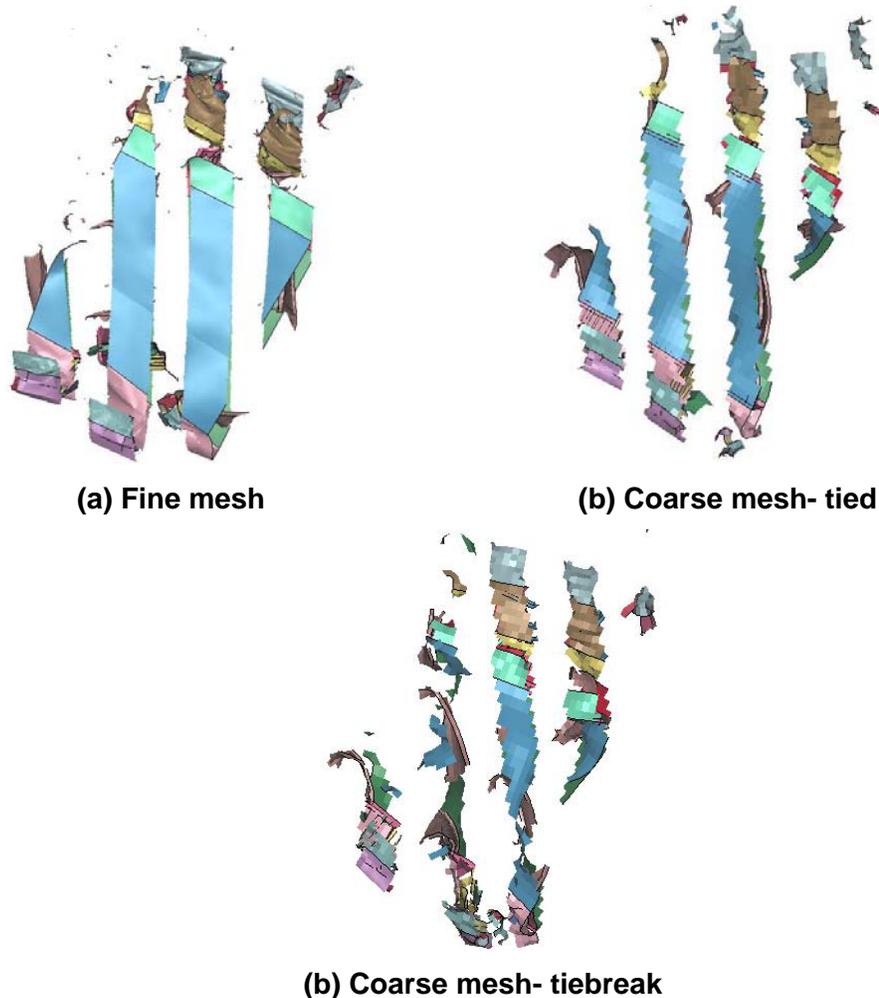
Figure 5–35. Fine and coarse mesh fragmentation.

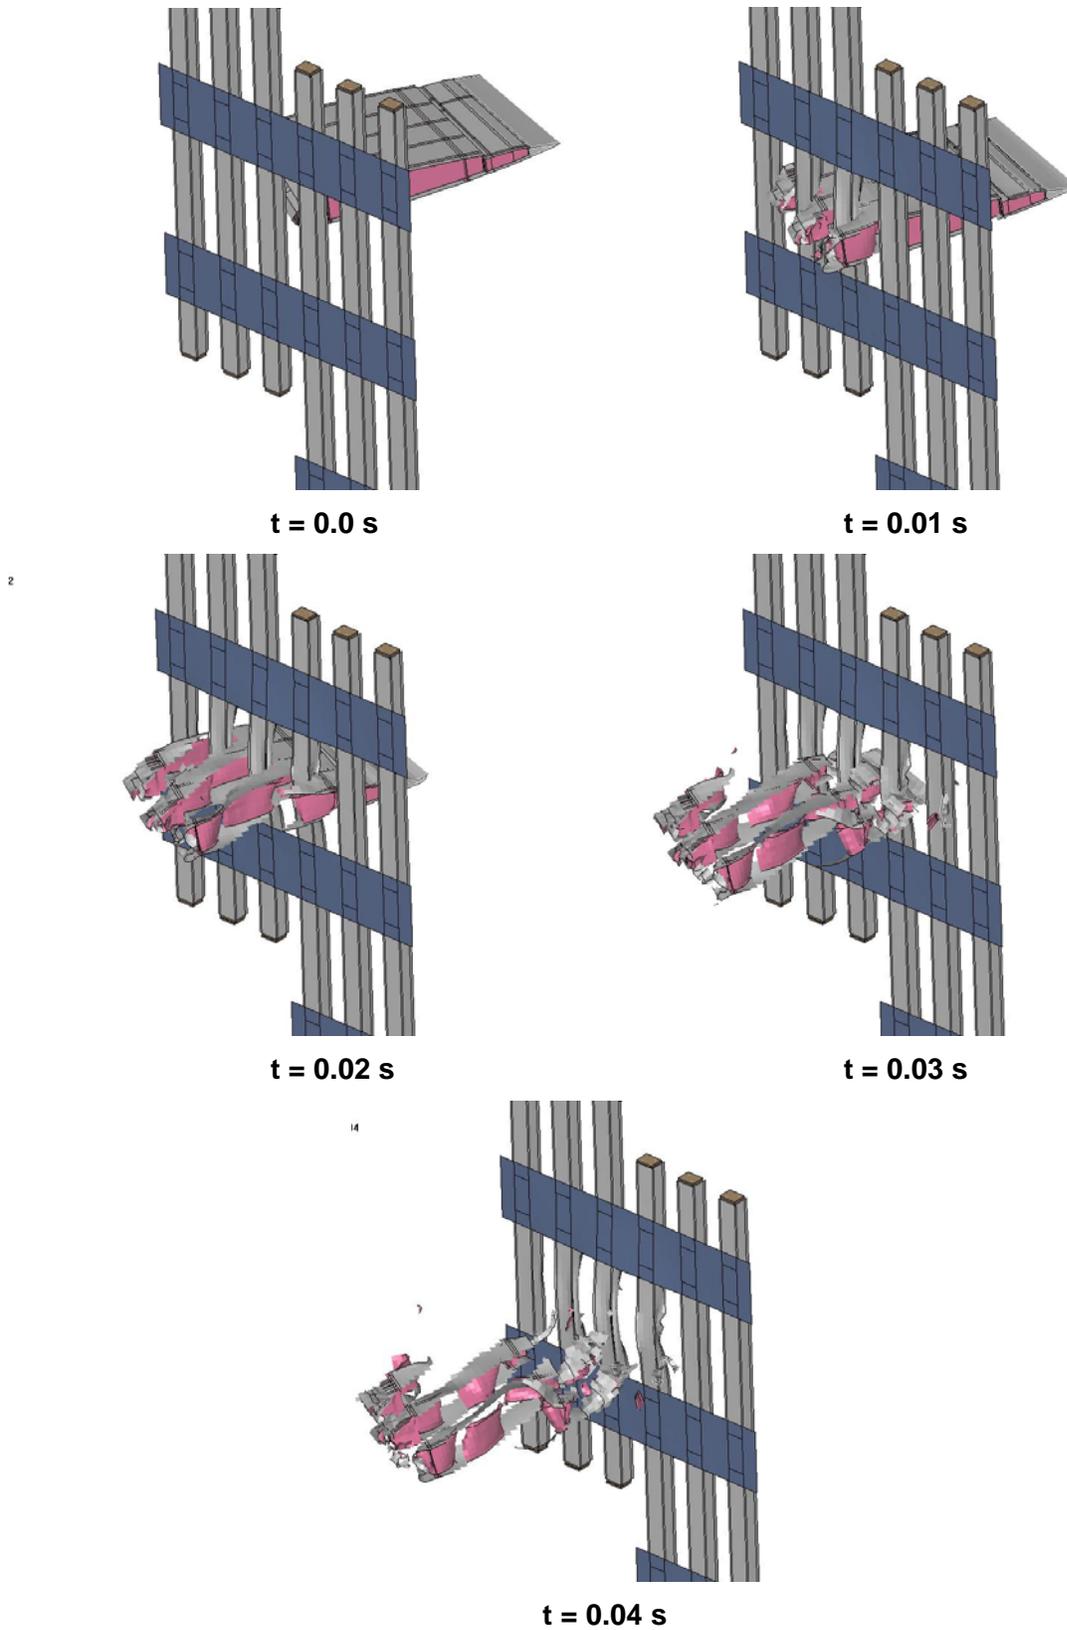
Figure 5–37. Calculated impact of a coarse-mesh empty wing section with two exterior panels at 442 mph.

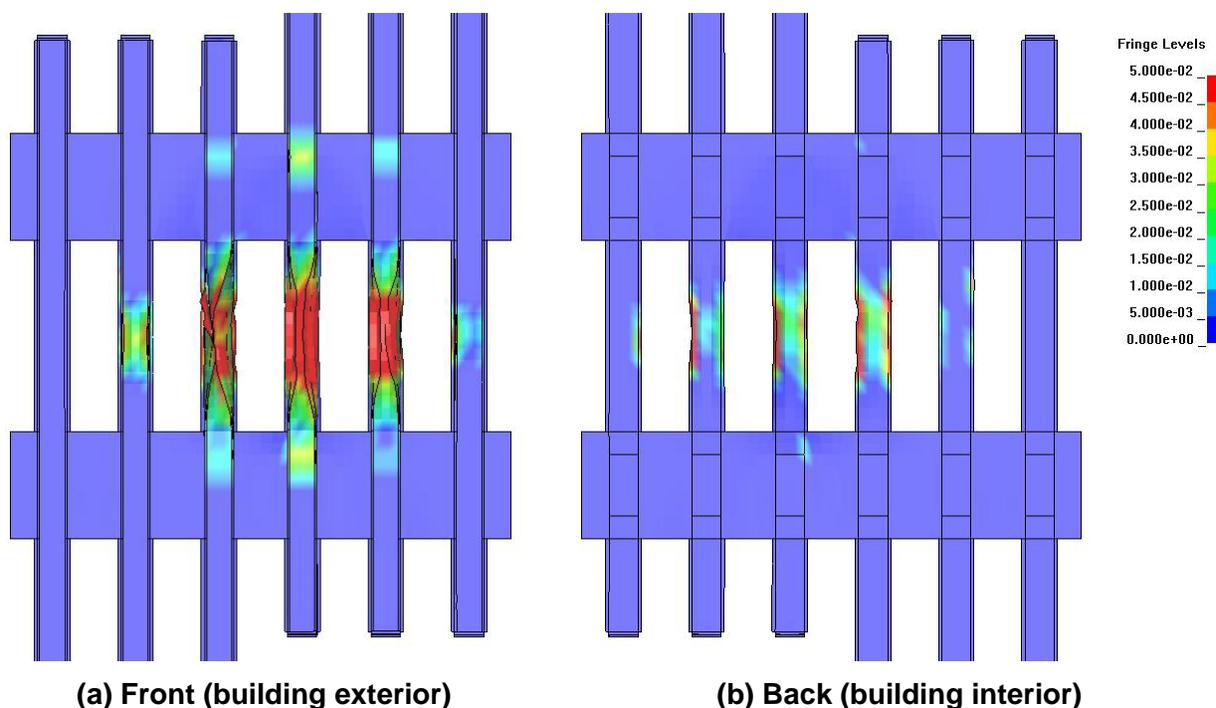
Figure 5–38. Impact damage to the exterior panel from a coarse-mesh empty wing section at 442 mph contours of effective plastic strain are shown.

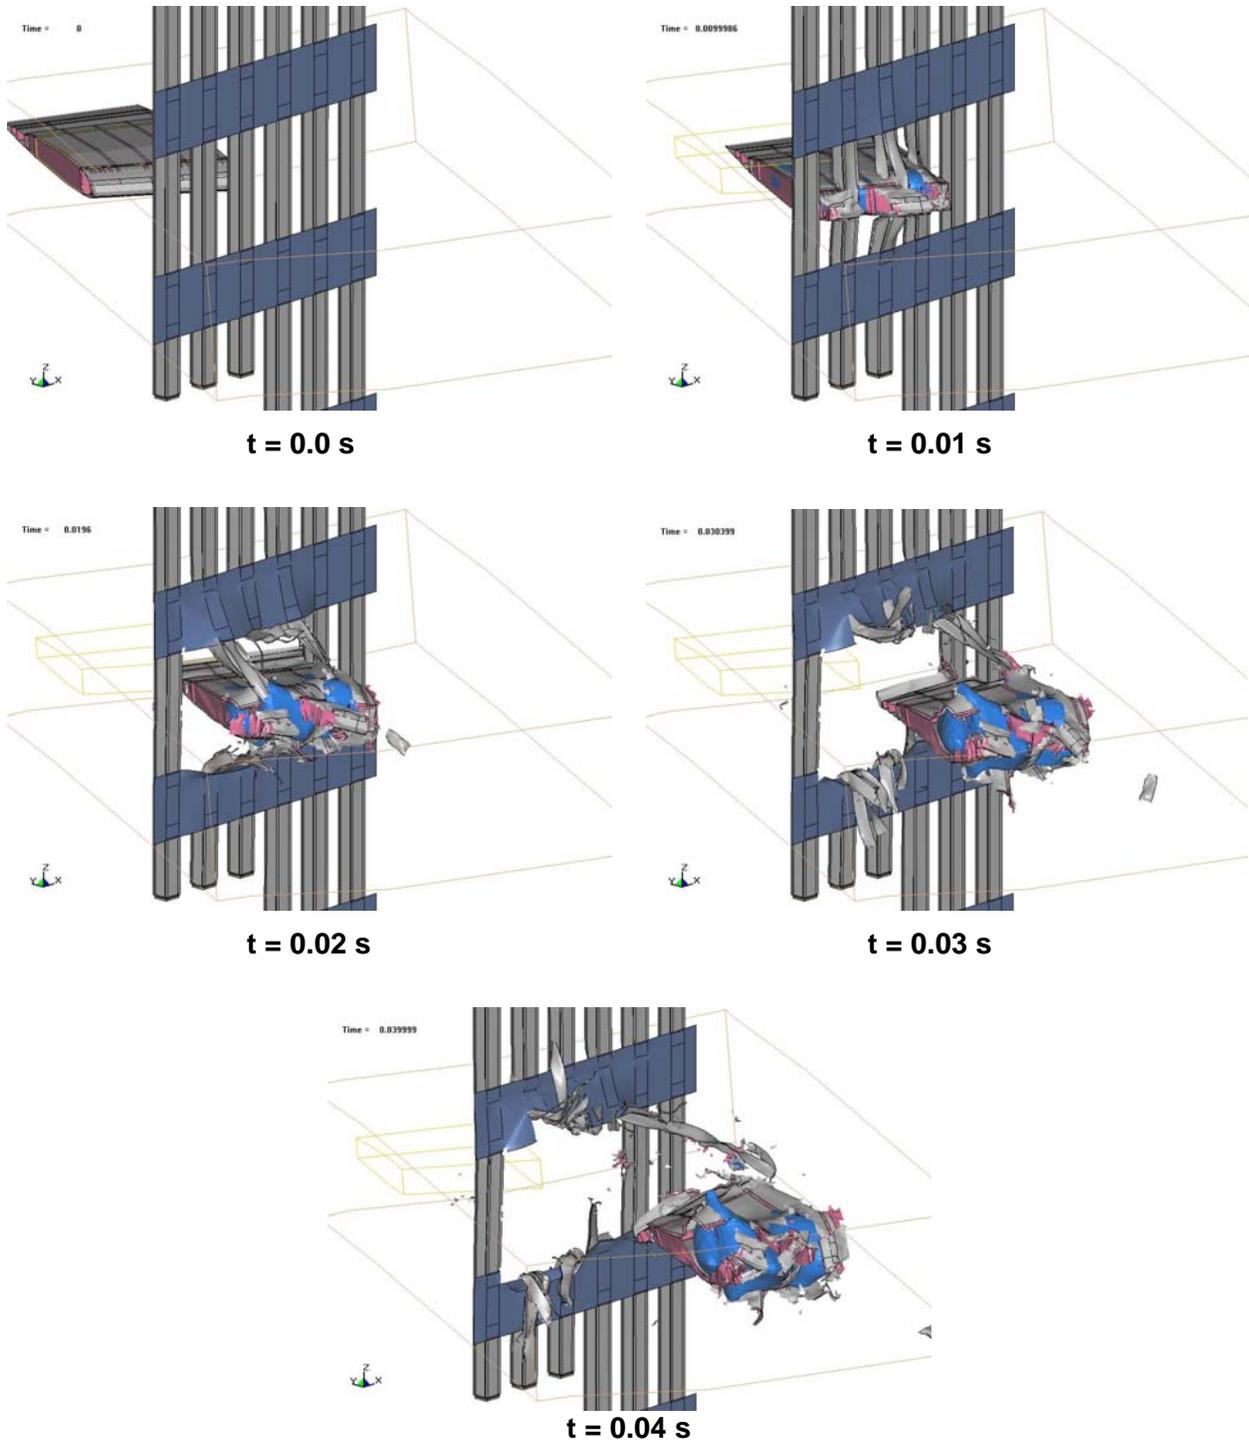
Figure 5–42. Calculated impact of a coarse mesh wing section laden with fuel modeled using ALE elements.

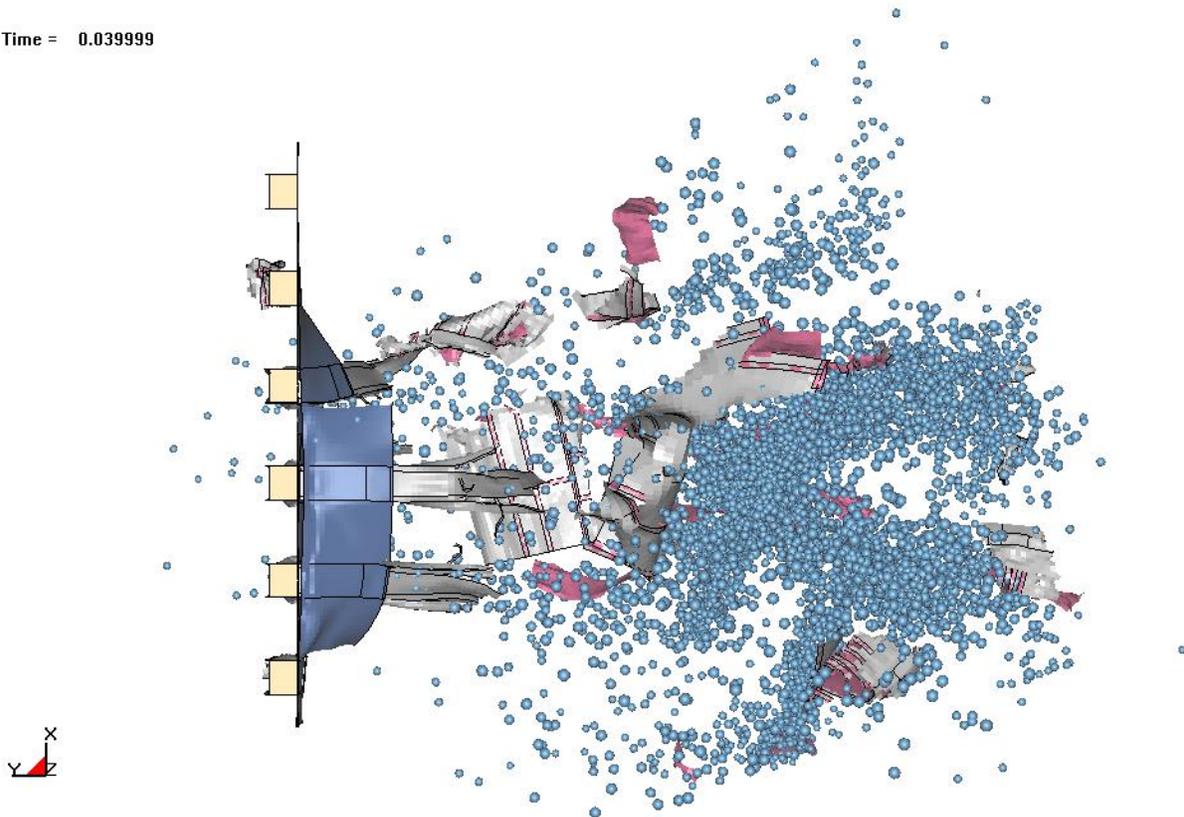
Figure 5–45. SPH analysis of structural damage and fuel dispersion at 0.04s (top view).

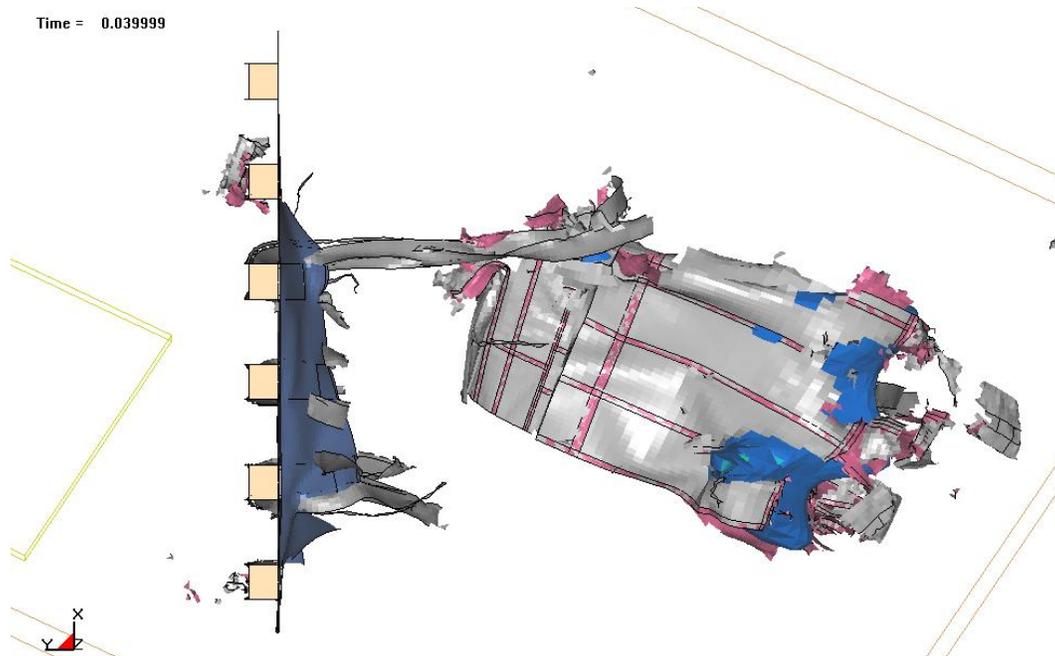
Figure 5–46. ALE analysis of structural damage and fuel dispersion at 0.04s (top view).

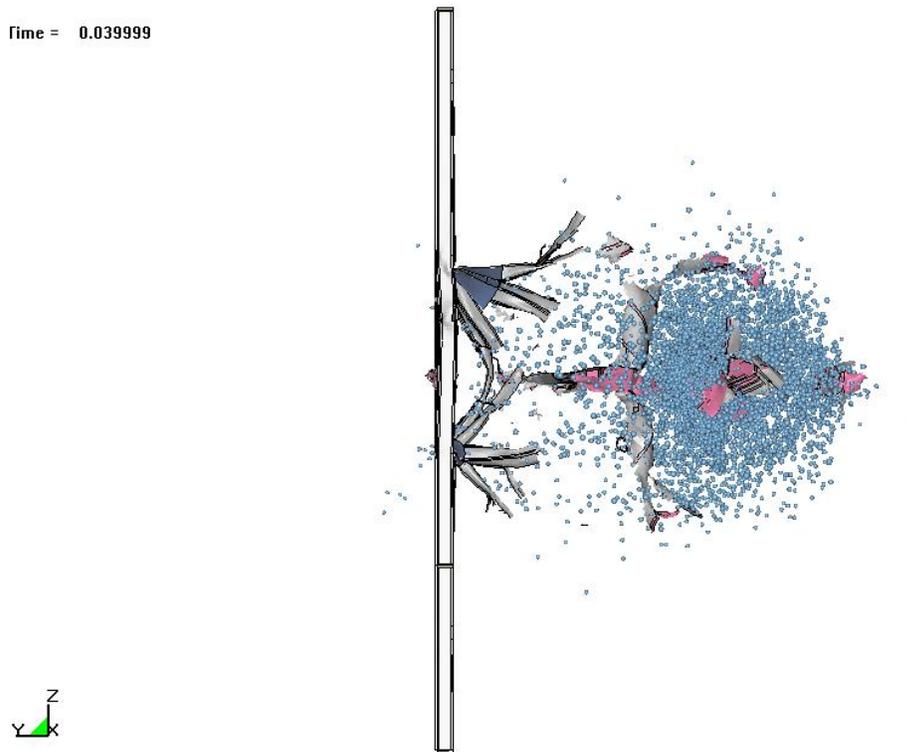
Figure 5–47. SPH analysis of structural damage and fuel dispersion (side view).

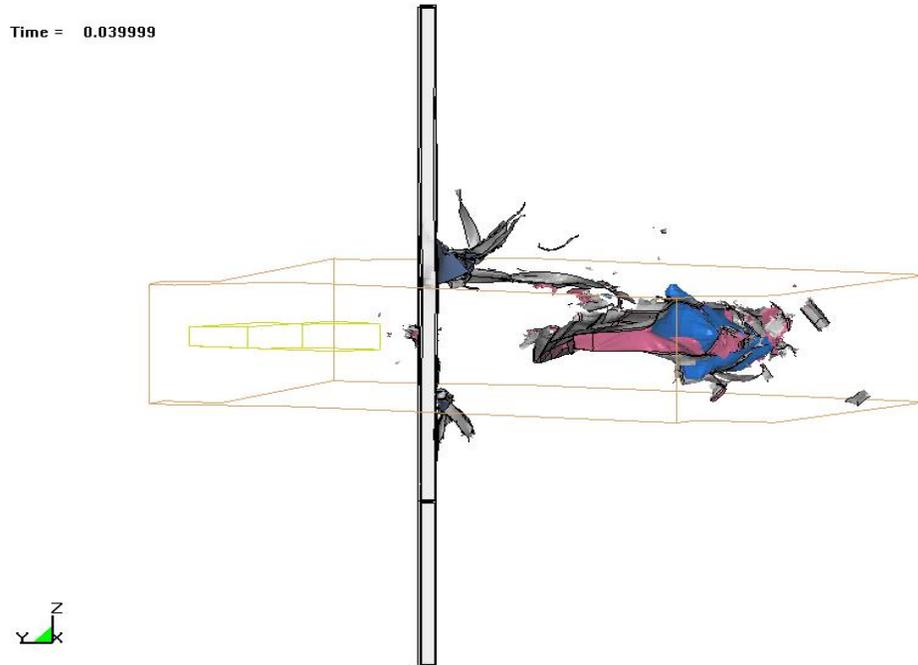
Figure 5–48. ALE analysis of structural damage and fuel dispersion (side view).

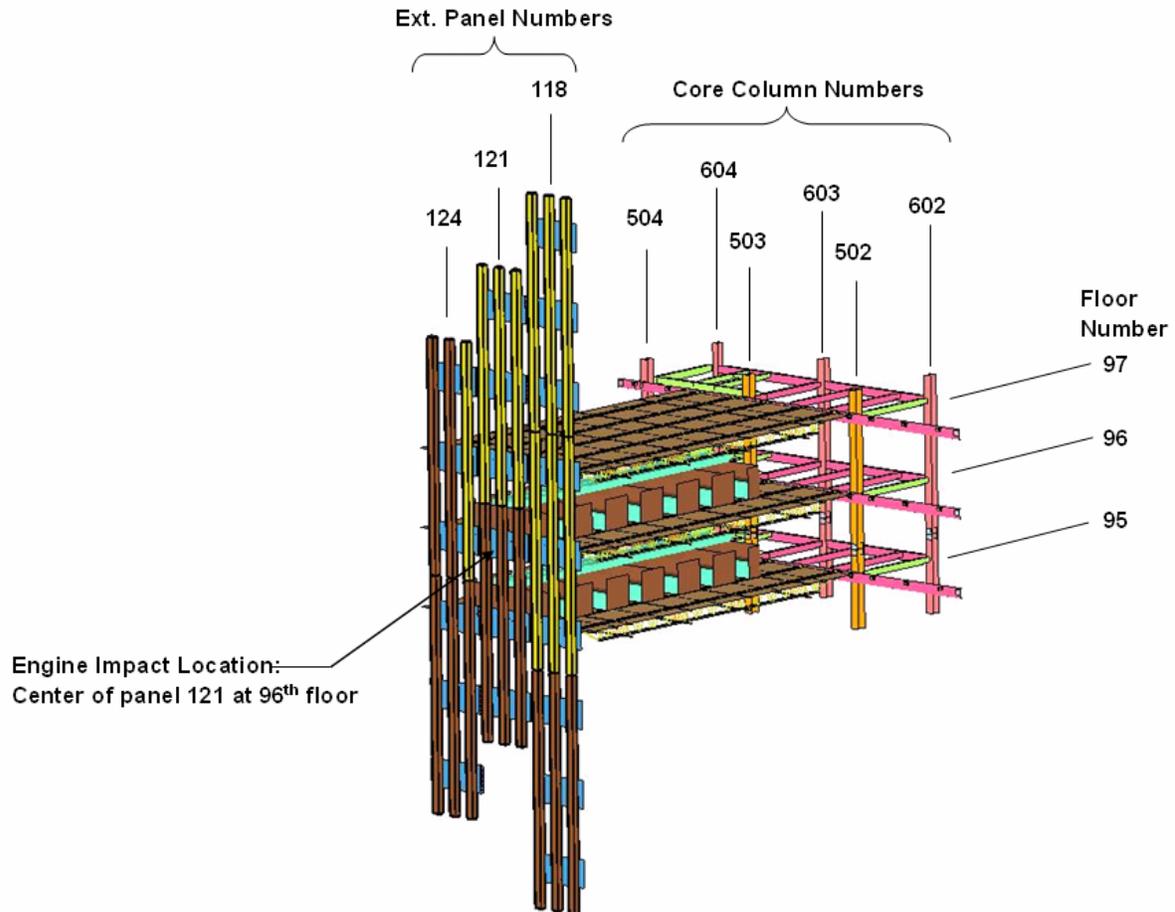
Figure 6–3. Final WTC tower subassembly model.

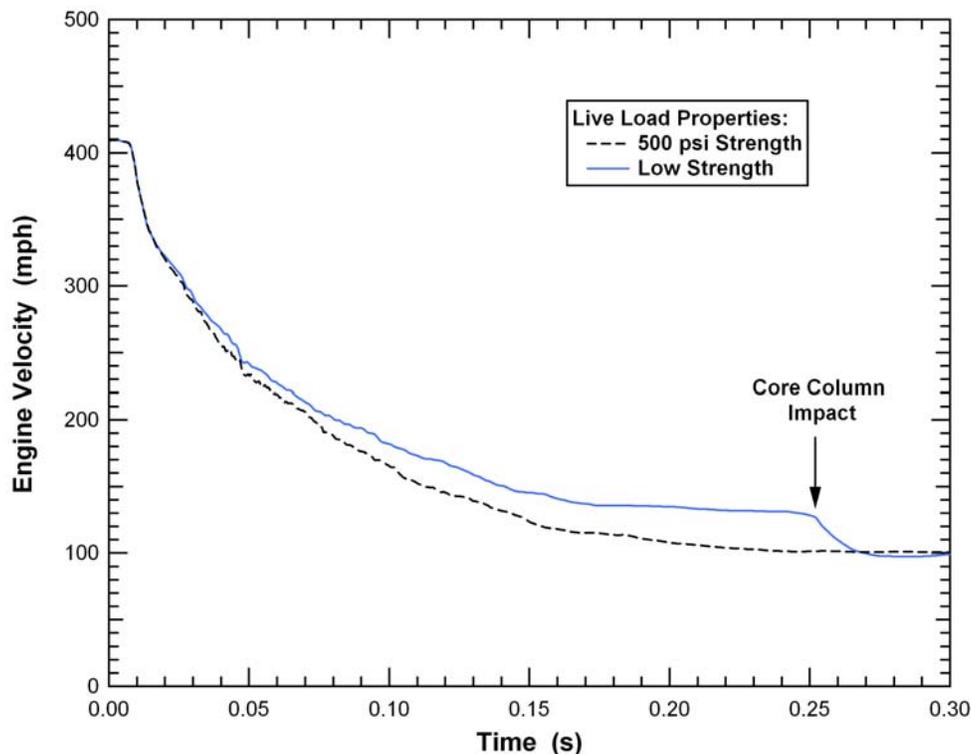
Figure 6–9. Effect of the building content strength on engine impact behavior.

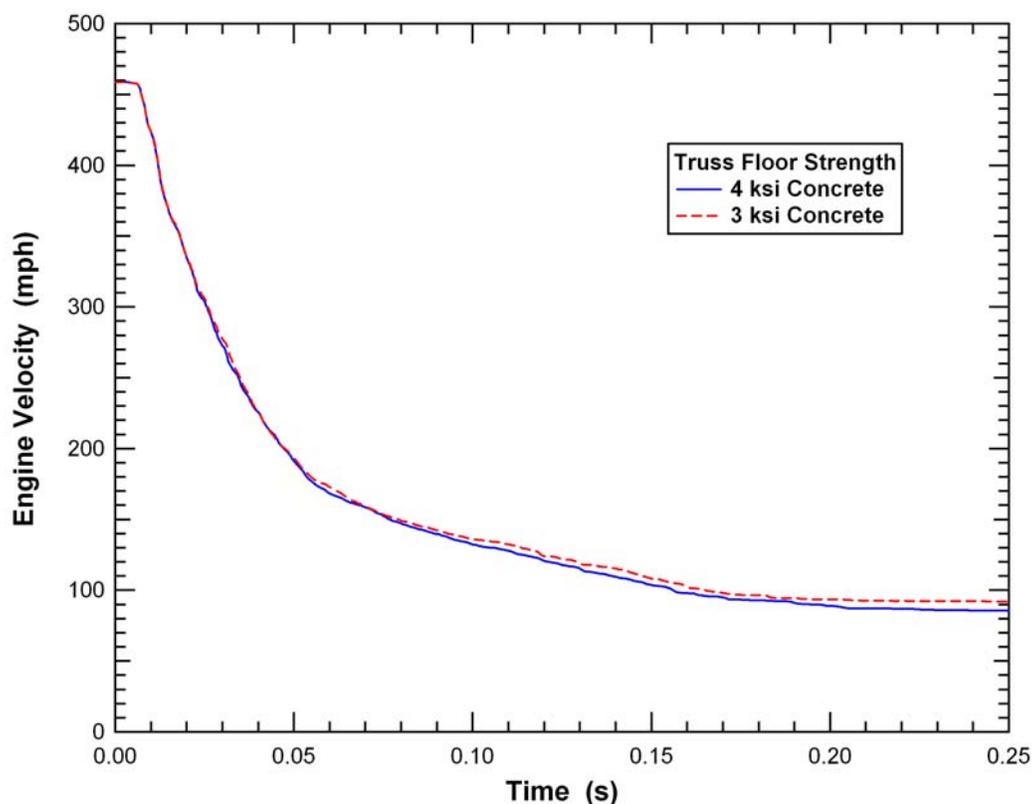
Figure 6–11. Effect of the concrete strength on engine impact behavior.

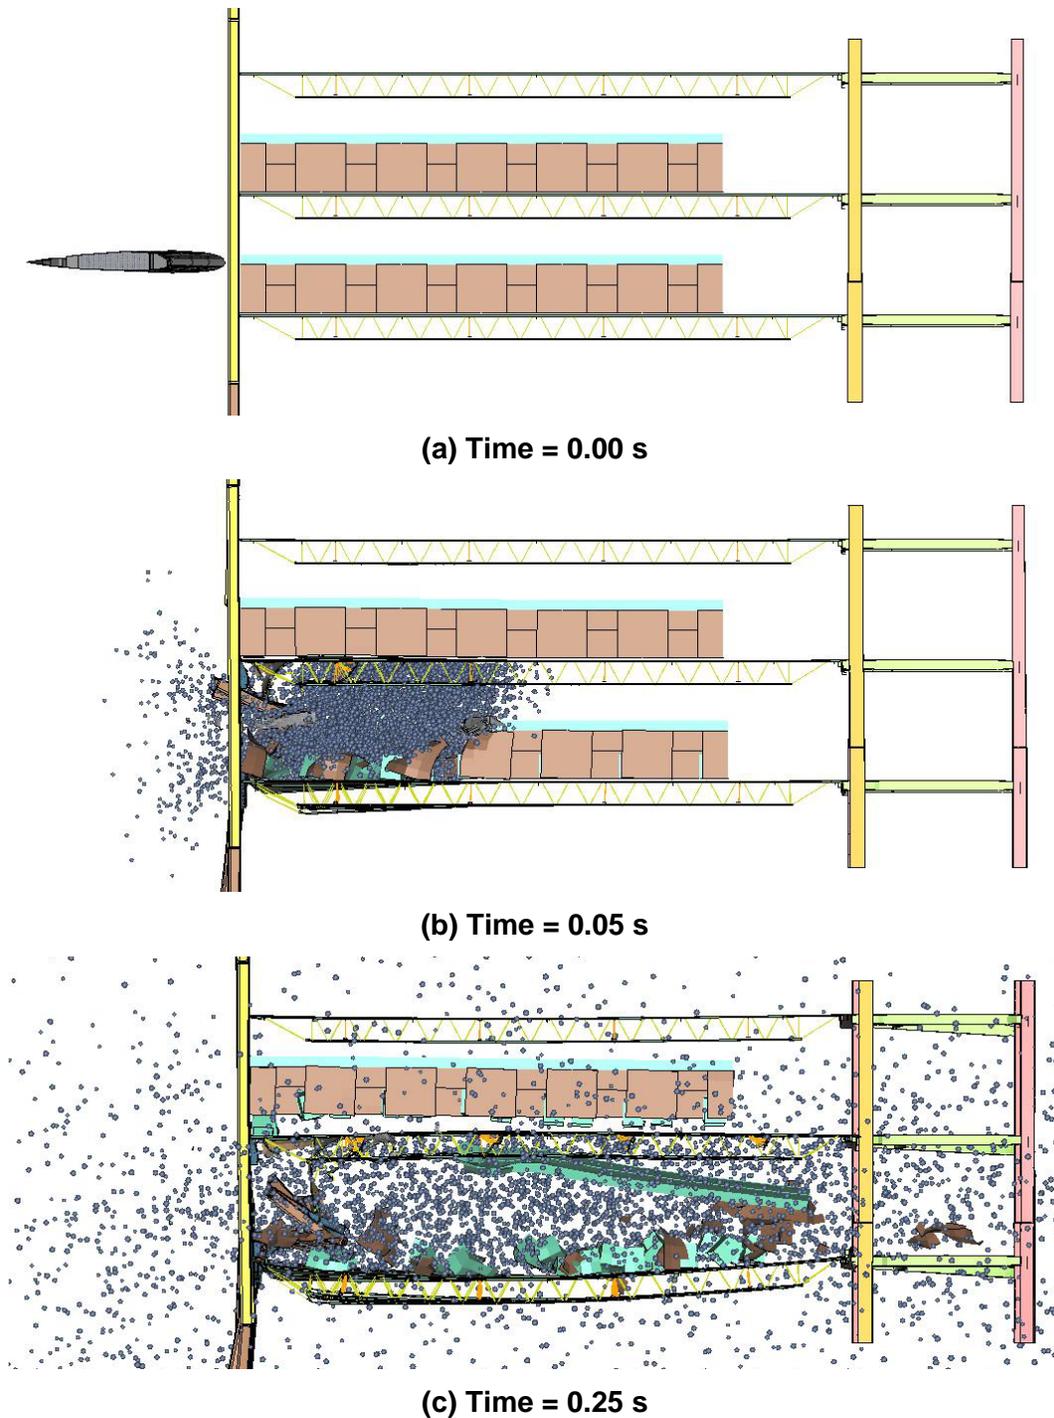
Figure 6–14. Baseline wing section impact and break up behavior (side view).
