NIST NCSTAR 1-2B

**Federal Building and Fire Safety Investigation of the
World Trade Center Disaster**

Analysis of Aircraft Impacts into the World Trade Center Towers

September 2005

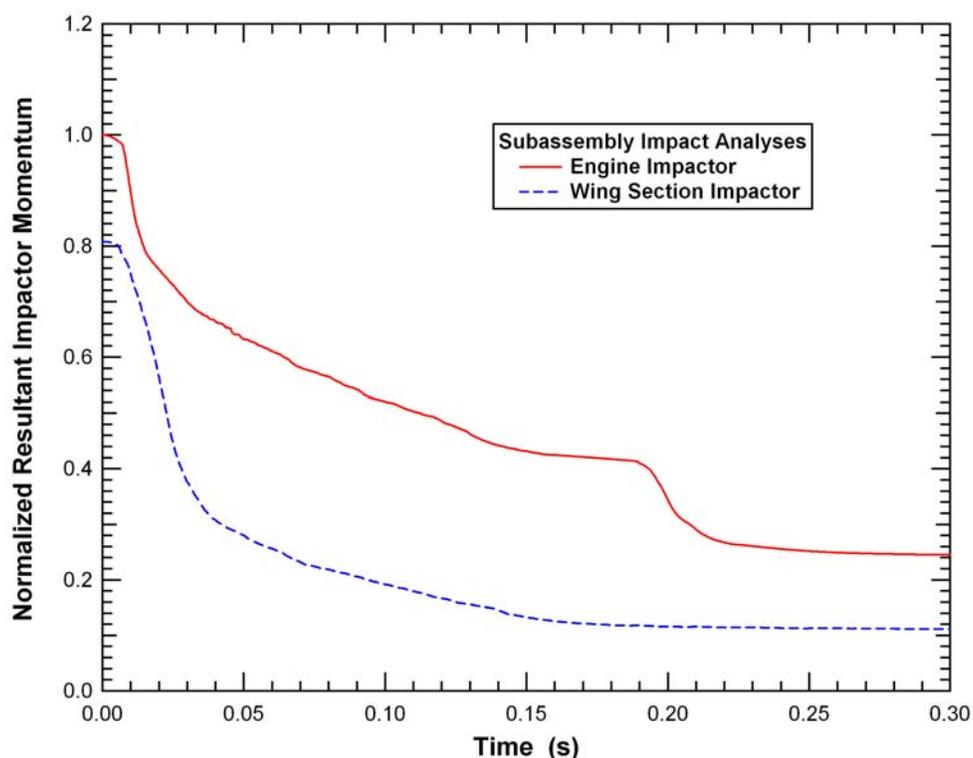
Figure 6–15. Impactor momentum histories for the engine and wing section analyses.

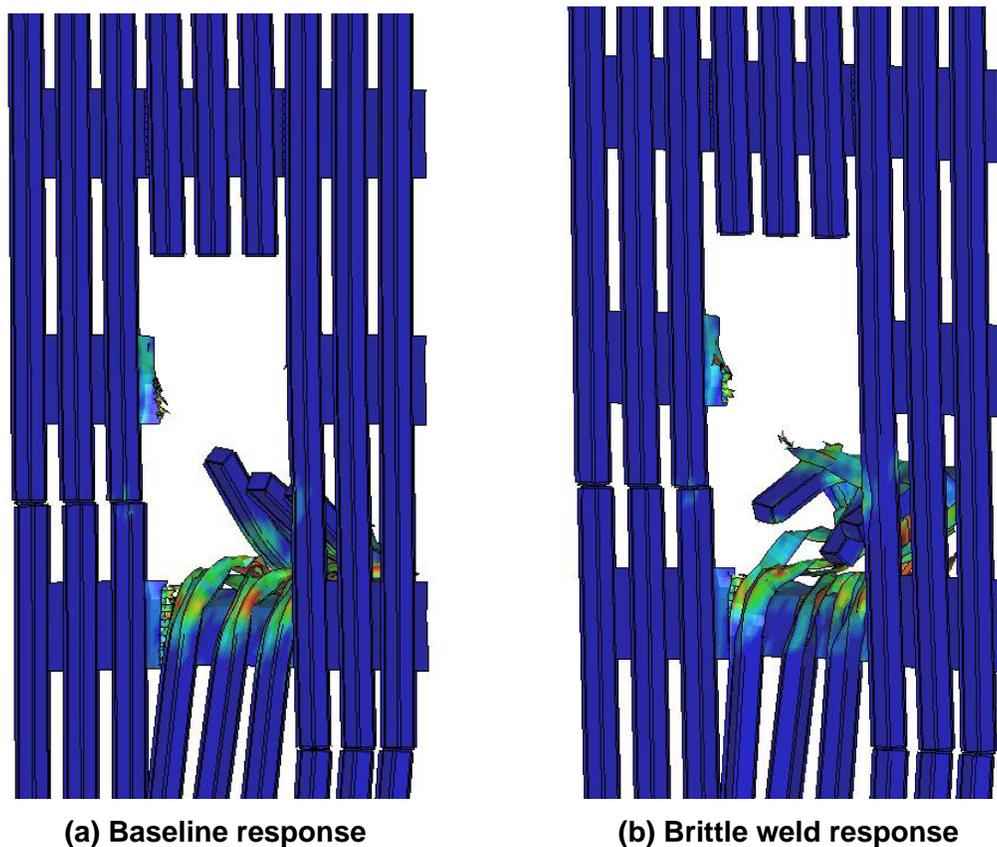
Figure 6–16. Exterior wall damage for the wing section impact analyses.

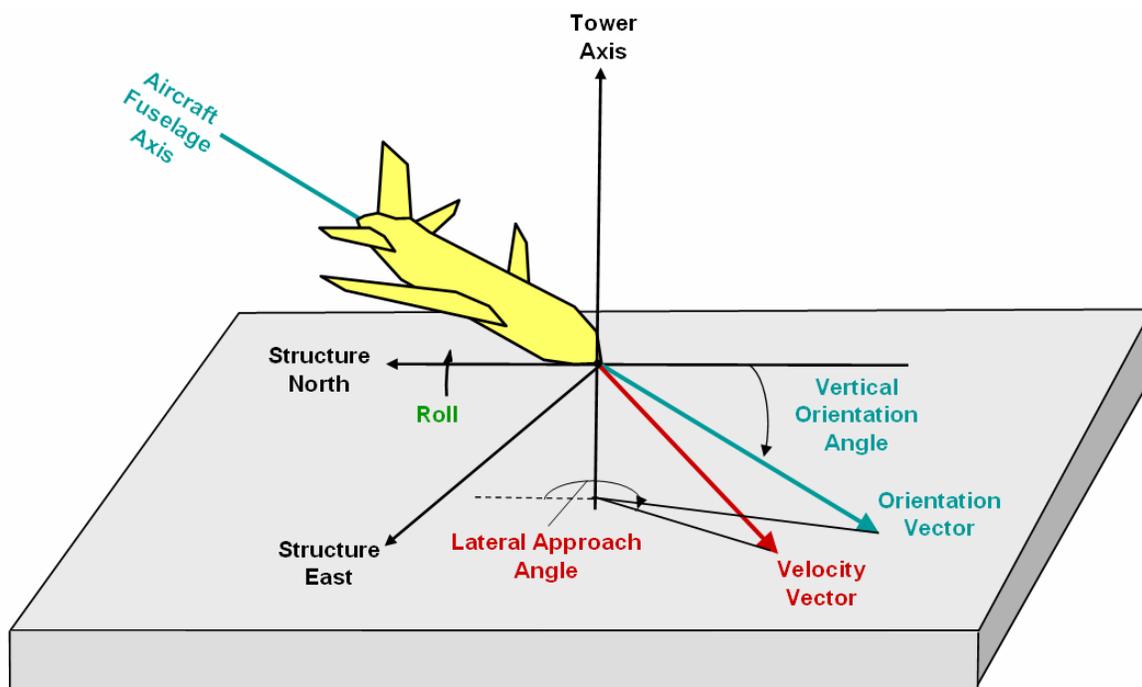
Figure 7–1. Definitions of the aircraft impact parameters.

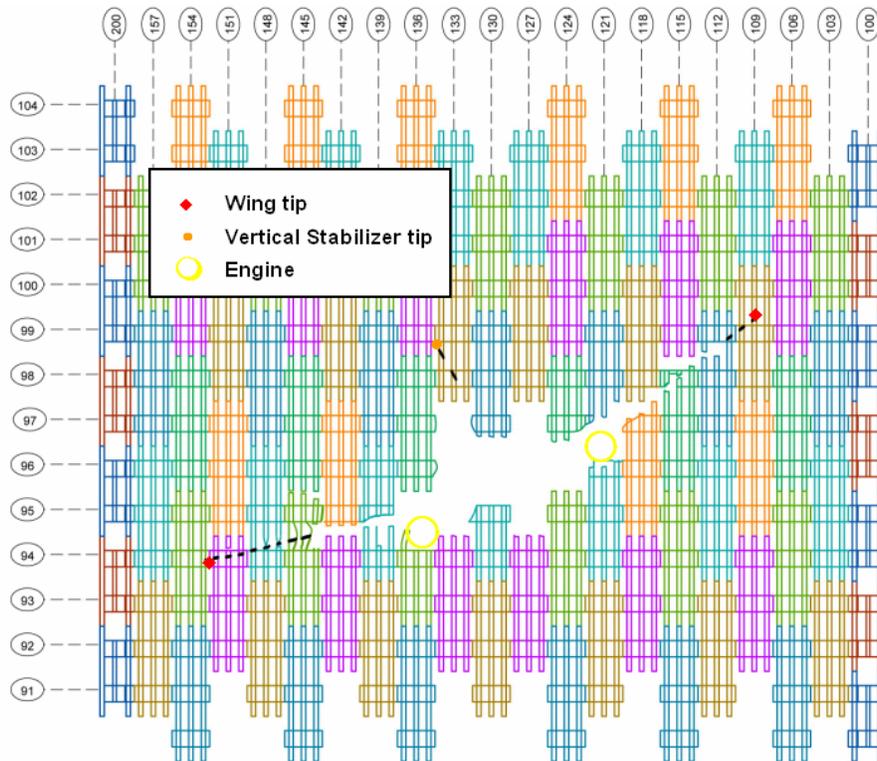
Figure 7-7. Estimated impact locations of aircraft components superimposed on the damaged face of WTC 1.

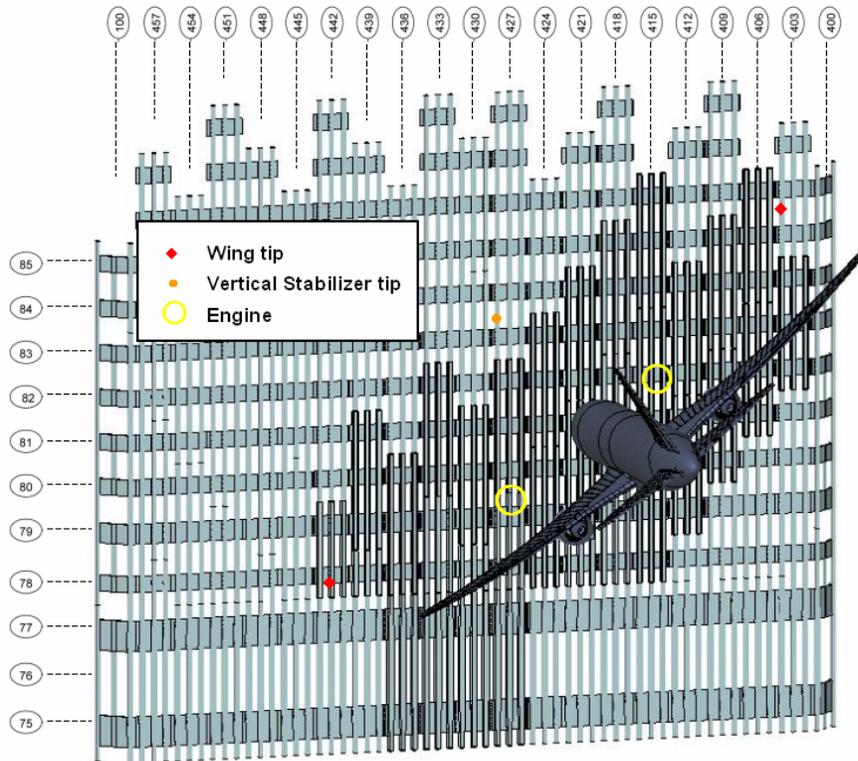
Figure 7-10. Baseline orientation and trajectory of UAL 175 from video analysis.

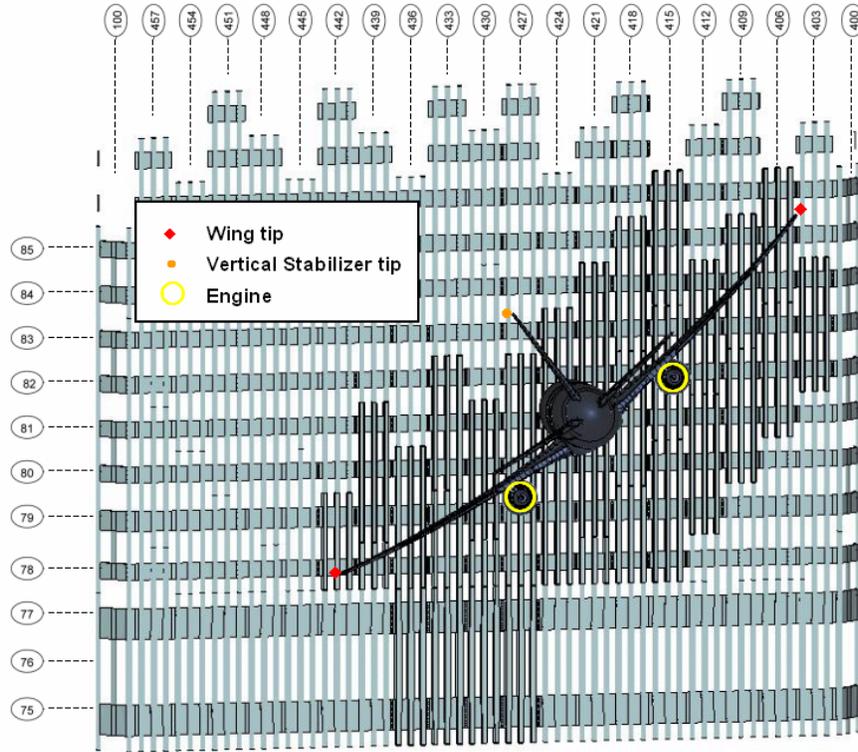
Figure 7-11. An orientation and trajectory of UAL 175 that matches the impact pattern (vertical approach angle = 6°, lateral approach angle = 13°).

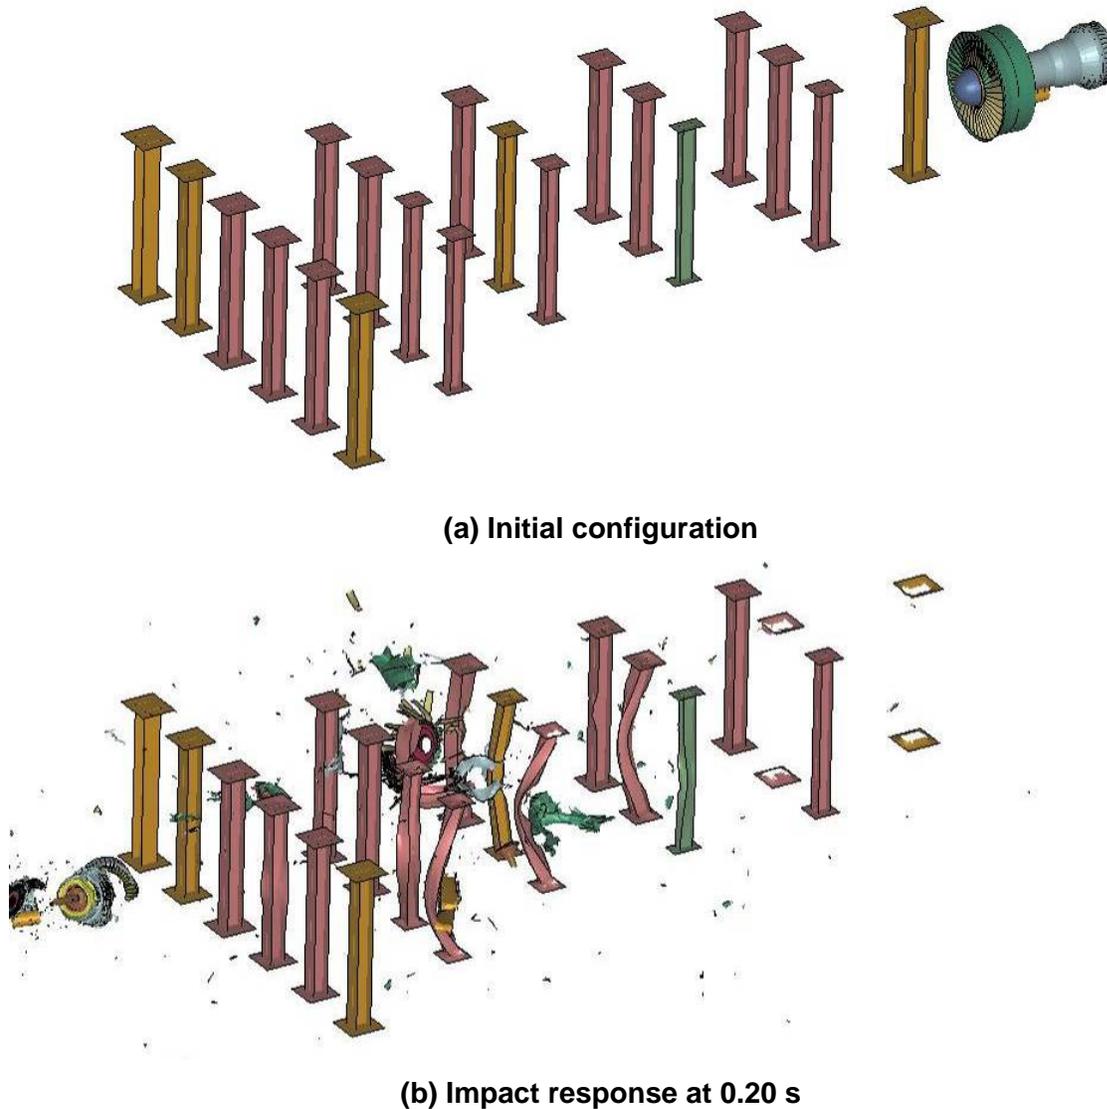
Figure 8–1. Example engine impact into an assembly of core columns.

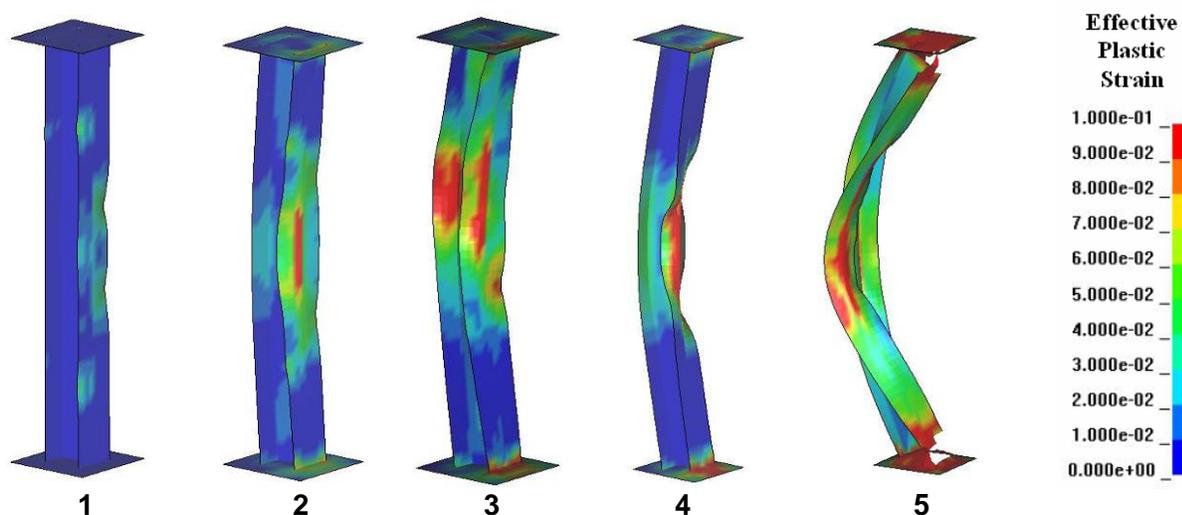
Figure 8–2. Measures of cross-section damage to a core column.

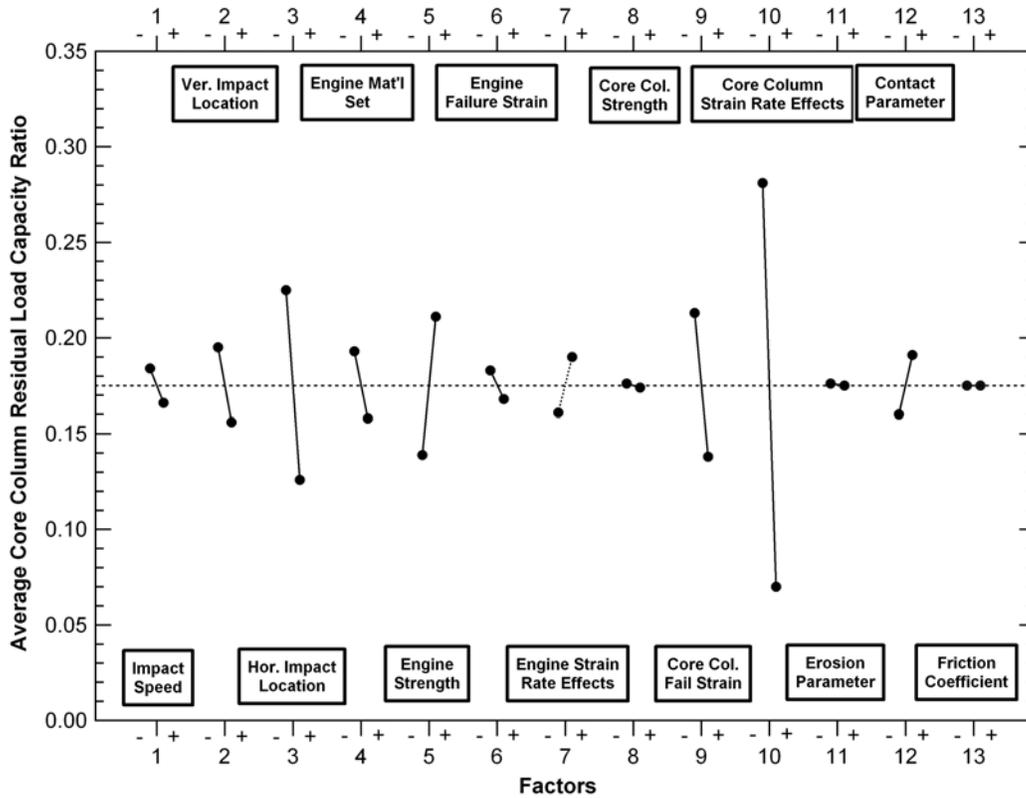
Figure 8-3. Main effects plot for the engine - core column impact analyses.

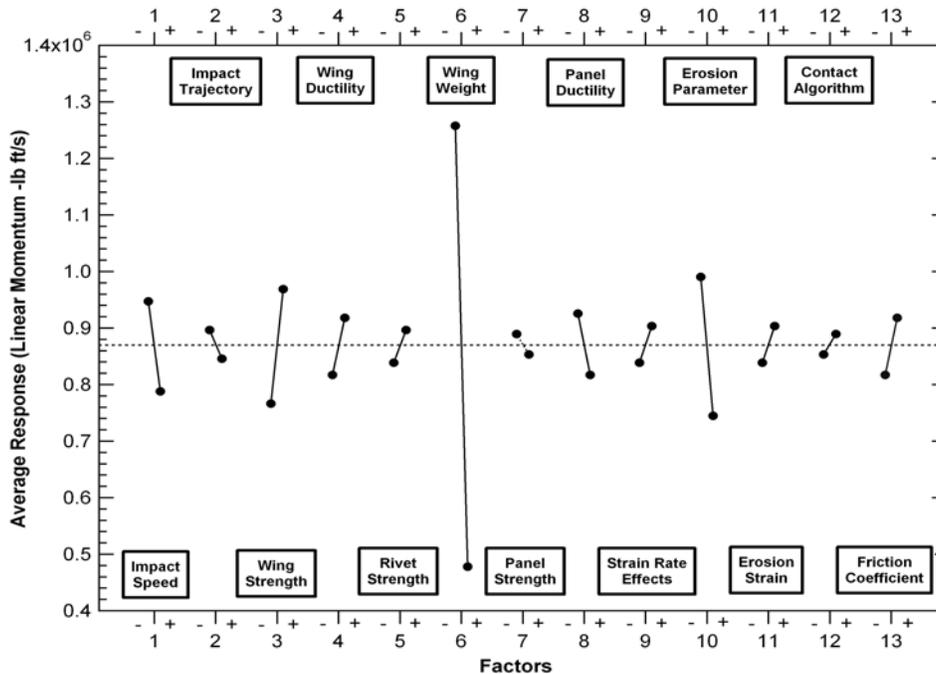
Figure 8–6. Main effects plot for the wing-panel impact analyses.
